RESOLUTION #97-10

DESIGNATION OF HAZARDOUS DEVELOPMENT SITE

## Fema/State Interagency Technical Report

### Boise County Debris Flow January 1-3, 1997

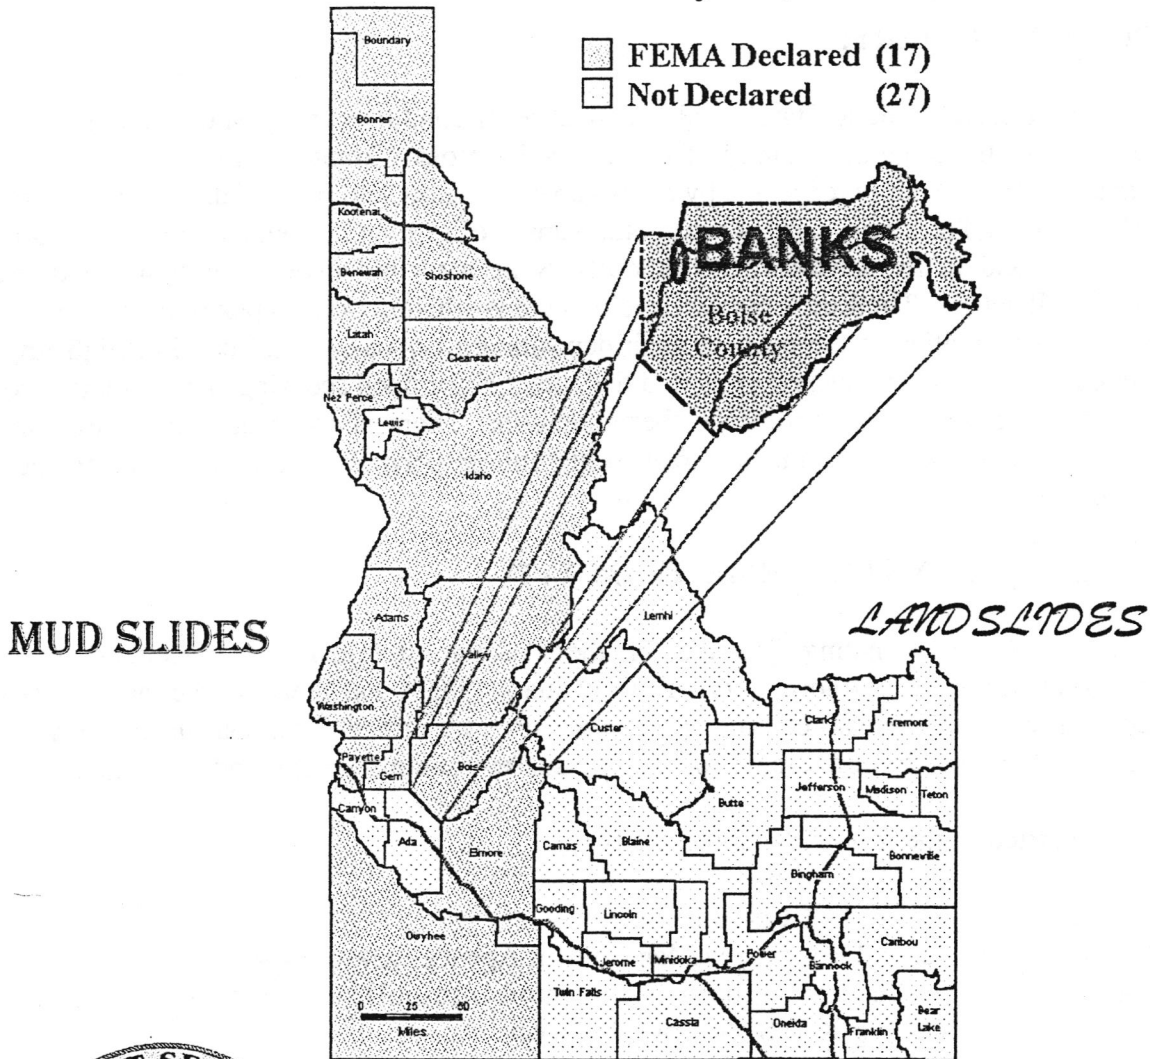
### Debris Flow Damage
