RESOLUTION #97-10

DESIGNATION OF HAZARDOUS DEVELOPMENT SITE

## Fema/State Interagency Technical Report

### Boise County Debris Flow January 1-3, 1997

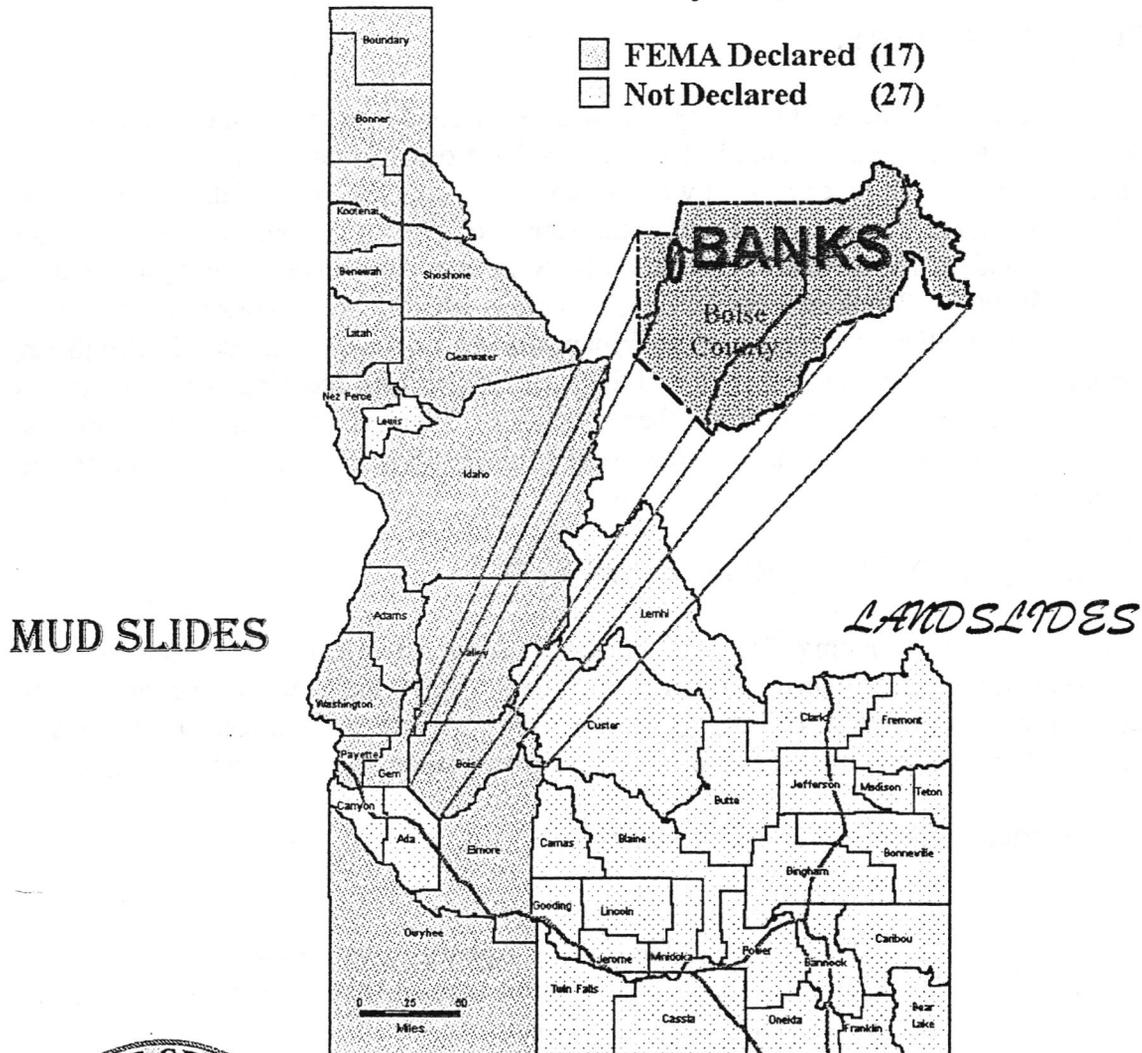
**Debris Flow Damage**

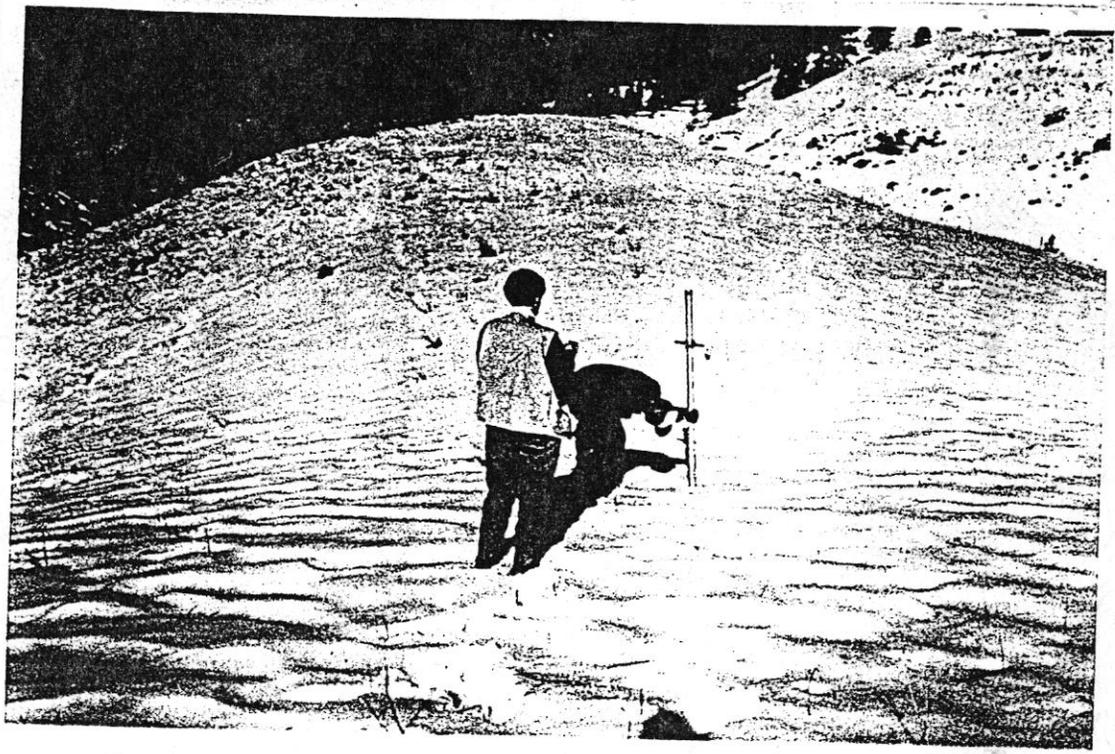
Top Photograph: Phil Morrisey (NRCS, Snow Survey Office) conducting snow survey in Lower Banks watershed. Lower Photograph: View of watershed areas above Lower Banks.

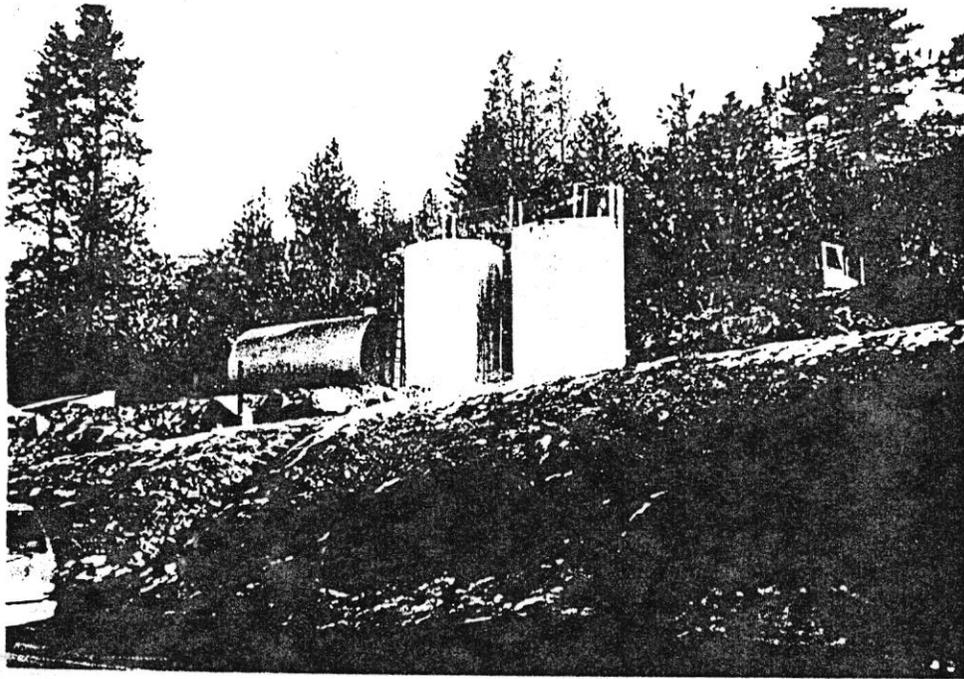
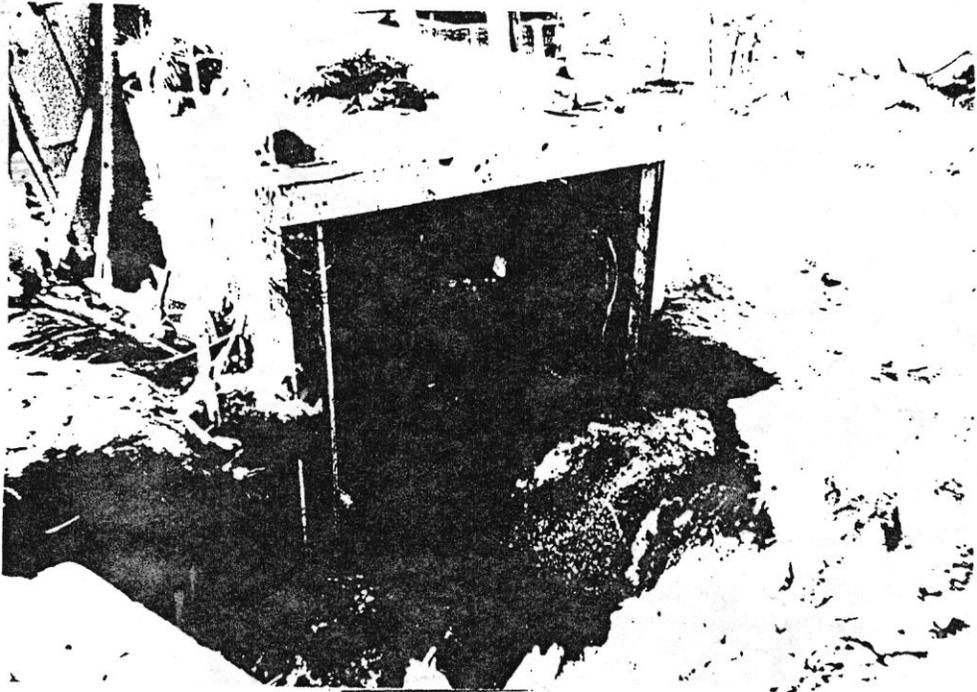
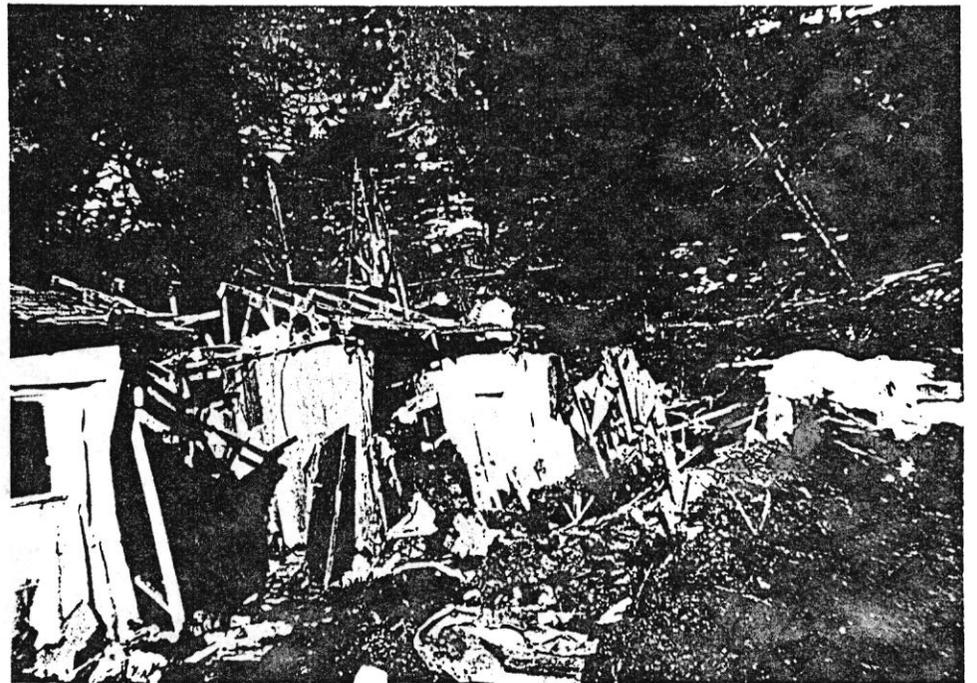
On January 1 - 3, 1997, a large volume of water and sediment passed from the main Banks Canyon onto the alluvial fan apex, then crossing Highway 55, and reaching the Payette river. The watershed contributed 12-14 acre feet of sediment and the water volume is estimated at 34.3 acre feet. Boulders up to five feet in diameter reached the area of the motel. Any structure on the alluvial fan that experienced this size-range of boulders was destroyed, as a

result. Other damage was caused by burial, due to the depth of the debris flow. This results in sediment and debris pouring through windows and doorways into structures, filling them with rock and mud. Scouring was also a problem, although it appeared that damage on the fan was mainly a factor of burial and impact forces.

Photographs of risk and damage in Lower Banks area.

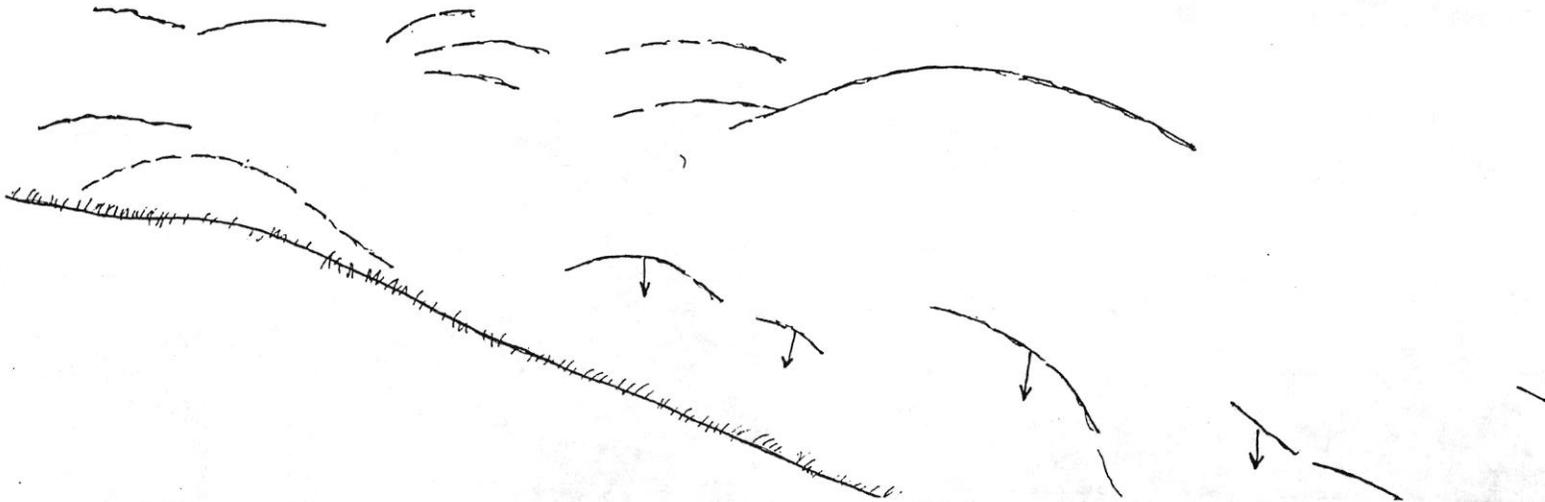
The snow-covered north-facing slopes are assumed to be underlain by frozen ground. This ground will thaw and will likely become unstable when that happens. The steeper slopes and more dense vegetation may contribute numerous slumps with tree debris into the channel bottom, which is assumed by the IAT to contribute to the ongoing imminent threat to human life below on the fan apex—in a sense, the second "barrel" of a "double-barrel shotgun."

TOP: Panoramic photograph of the north-facing slope of the main canyon above Lower Banks. Note the slump scarps in frozen soil. Undercut lower slopes slumped into the stream bottom, as shown. BOTTOM: Outline sketch of scarps shown in photograph above.
