RESOLUTION #97-12

DESIGNATION OF HAZARDOUS DEVELOPMENT SITE

## TECHNICAL EVALUATION

### ALLUVIAL FAN COMPLEX DEBRIS FLOOD/FLOW POTENTIAL

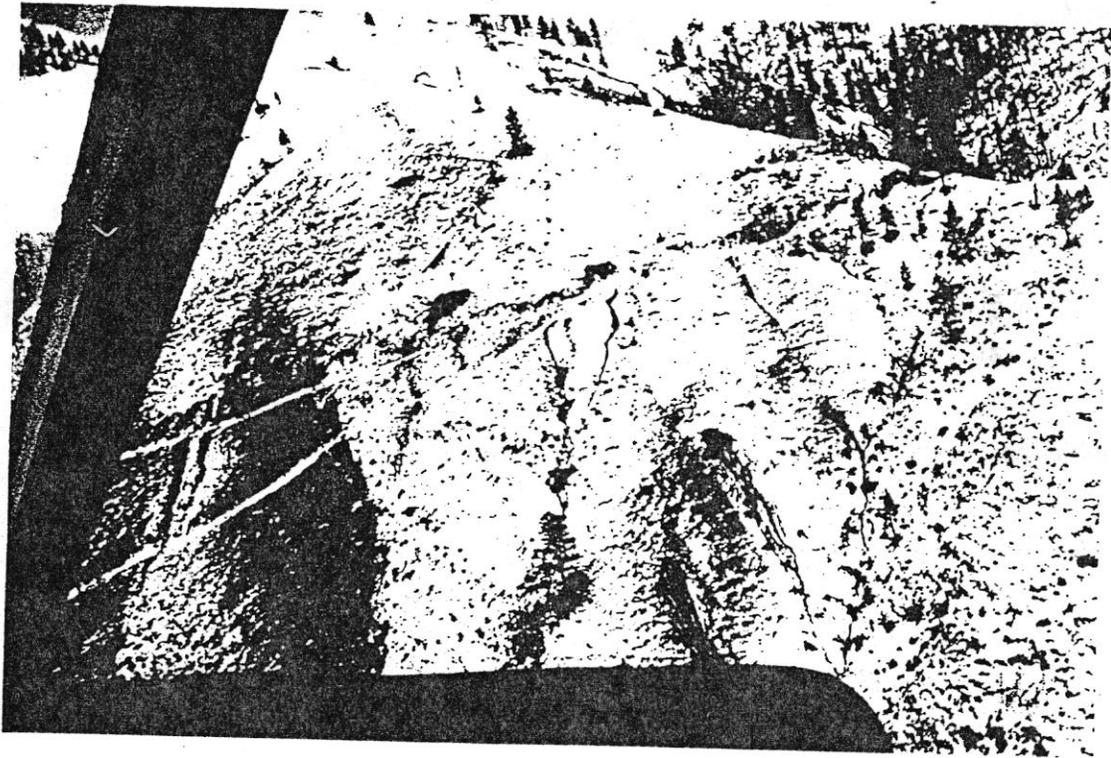
The Lower Banks watersheds are considered by the IAT to be damaged. This is an important point that relates to the concept of imminent threat to life and property, even on an ongoing basis for several years to come. The damage resulted from the deep and extensive burn that occurred five years ago, and from which the trees of the watershed have not yet recovered. The damage also resulted from the December and early January weather, snow and rainfall, and warm temperatures. The watershed reacted to the latter conditions with rapid runoff, undercutting of stream banks, slumping, natural dams, and flood surges onto the alluvial fan below. Many active and incipient slumps still exist on the south-facing slopes of the two canyons, and evidence of slumping is present in the north-facing frozen slopes.

Top Photograph: Phil Morrisey (NRCS, Snow Survey Office) conducting snow survey in Lower Banks watershed. Lower Photograph: View of watershed areas above Lower Banks.

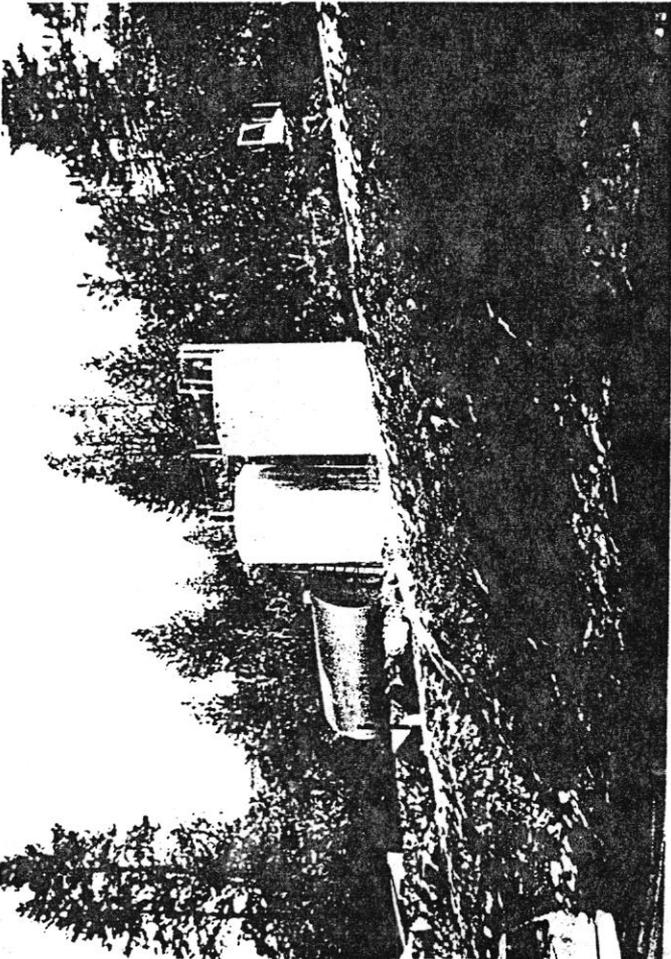
On January 1 - 3, 1997, a large volume of water and sediment passed from the main Banks Canyon onto the alluvial fan apex, then crossing Highway 55, and reaching the Payette river. The watershed contributed 12-14 acre feet of sediment and the water volume is estimated at 34.3 acre feet. Boulders up to five feet in diameter reached the area of the motel. Any structure on the alluvial fan that experienced this size-range of boulders was destroyed, as a

result. Other damage was caused by burial, due to the depth of the debris flow. This results in sediment and debris pouring through windows and doorways into structures, filling them with rock and mud. Scouring was also a problem, although it appeared that damage on the fan was mainly a factor of burial and impact forces.

Photographs of risk and damage in Lower Banks area.

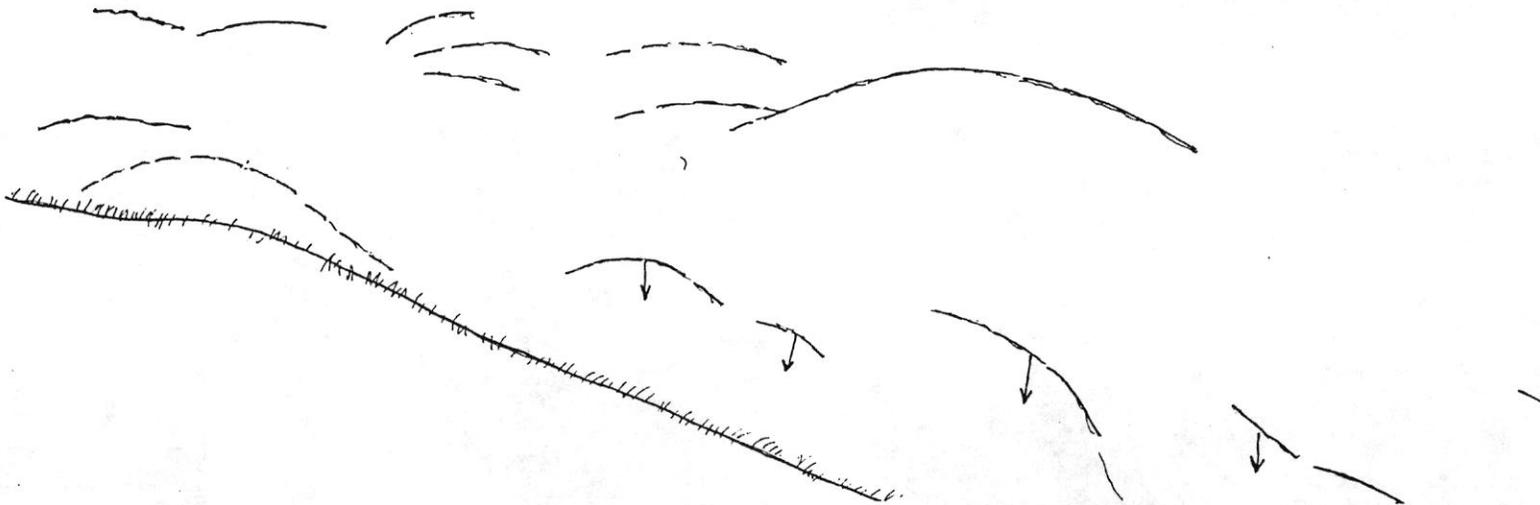
The snow-covered north-facing slopes are assumed to be underlain by frozen ground. This ground will thaw and will likely become unstable when that happens. The steeper slopes and more dense vegetation may contribute numerous slumps with tree debris into the channel bottom, which is assumed by the IAT to contribute to the ongoing imminent threat to human life below on the fan apex—in a sense, the second "barrel" of a "double-barrel shotgun."

TOP: Panoramic photograph of the north-facing slope of the main canyon above Lower Banks. Note the slump scarps in frozen soil. Undercut lower slopes slumped into the stream bottom, as shown. BOTTOM: Outline sketch of scarps shown in photograph above.
