RESOLUTION #97-12

DESIGNATION OF HAZARDOUS DEVELOPMENT SITE

## Fema/State Interagency Technical Report

### Boise County Debris Flow

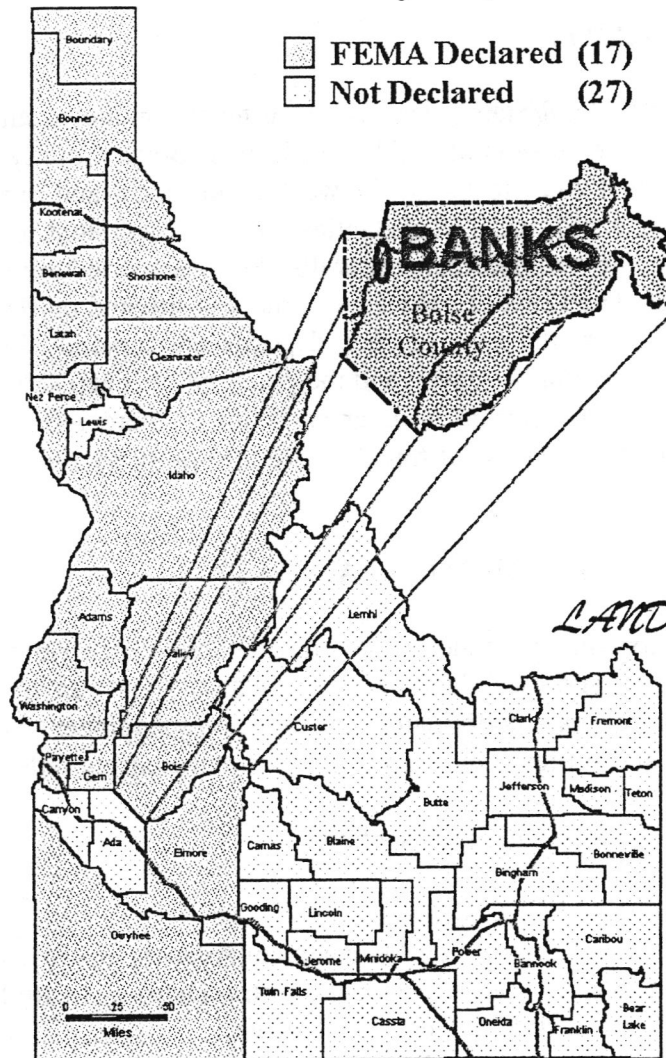
Debris Flow Damage
