RESOLUTION #97-19

DESIGNATION OF HAZARDOUS DEVELOPMENT SITE

TECHNICAL EVALUATION

ALLUVIAL FAN COMPLEX DEBRIS FLOOD/FLOW POTENTIAL

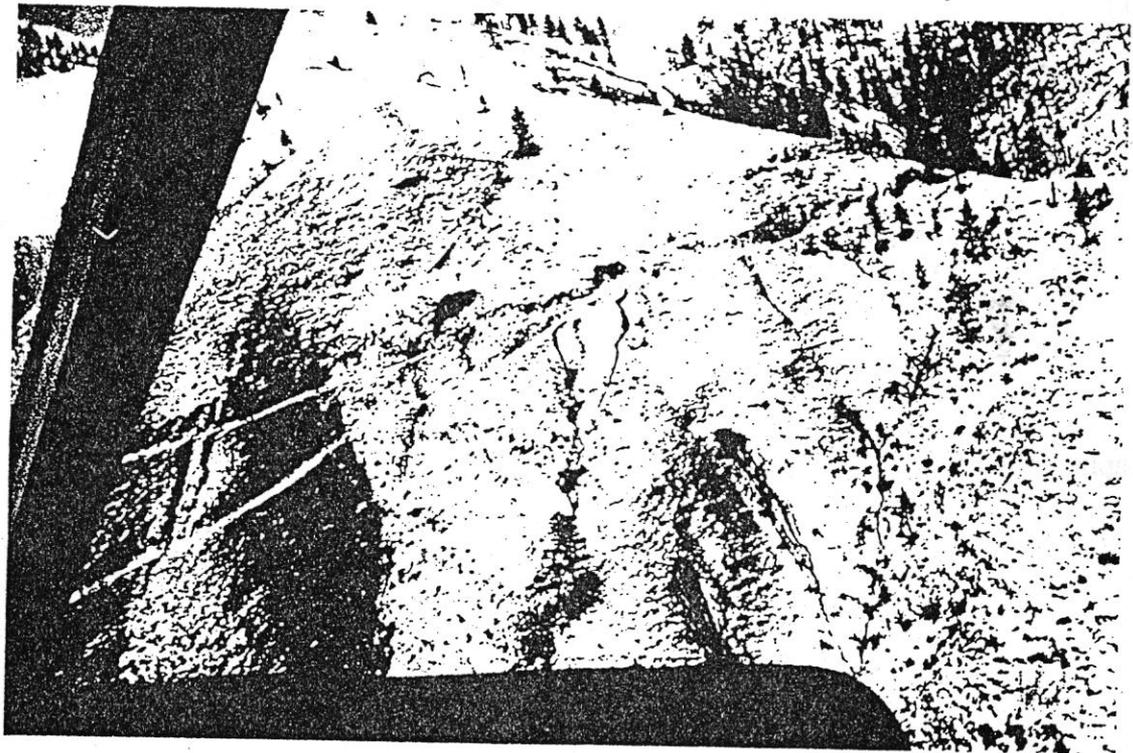
The Lower Banks watersheds are considered by the IAT to be damaged. This is an important point that relates to the concept of imminent threat to life and property, even on an ongoing basis for several years to come. The damage resulted from the deep and extensive burn that occurred five years ago, and from which the trees of the watershed have not yet recovered. The damage also resulted from the December and early January weather, snow and rainfall, and warm temperatures. The watershed reacted to the latter conditions with rapid runoff, undercutting of stream banks, slumping, natural dams, and flood surges onto the alluvial fan below. Many active and incipient slumps still exist on the south-facing slopes of the two canyons, and evidence of slumping is present in the north-facing frozen slopes.

Top Photograph: Phil Morrisey (NRCS, Snow Survey Office) conducting snow survey in Lower Banks watershed. Lower Photograph: View of watershed areas above Lower Banks.

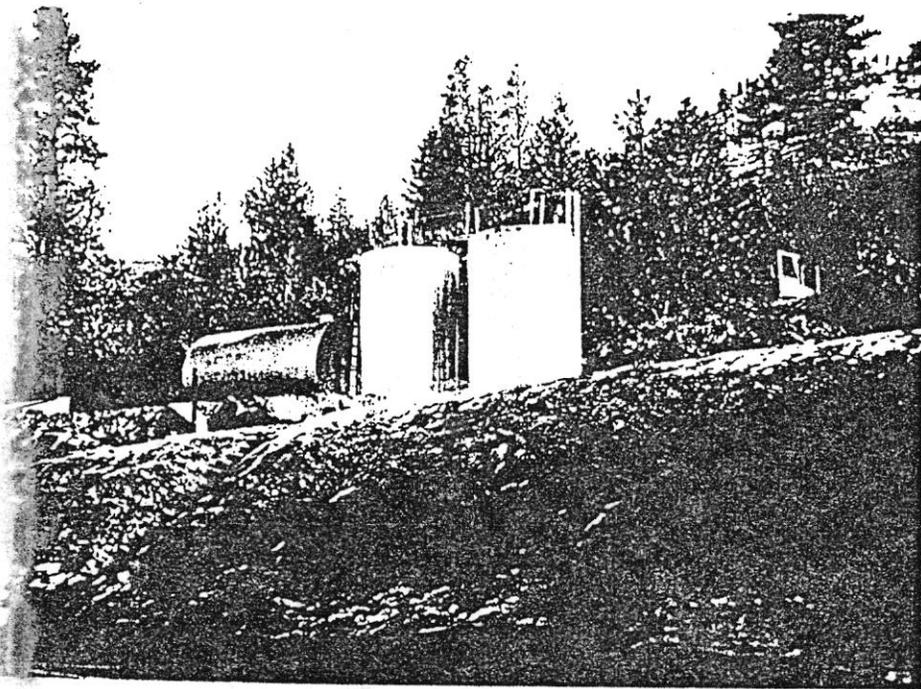
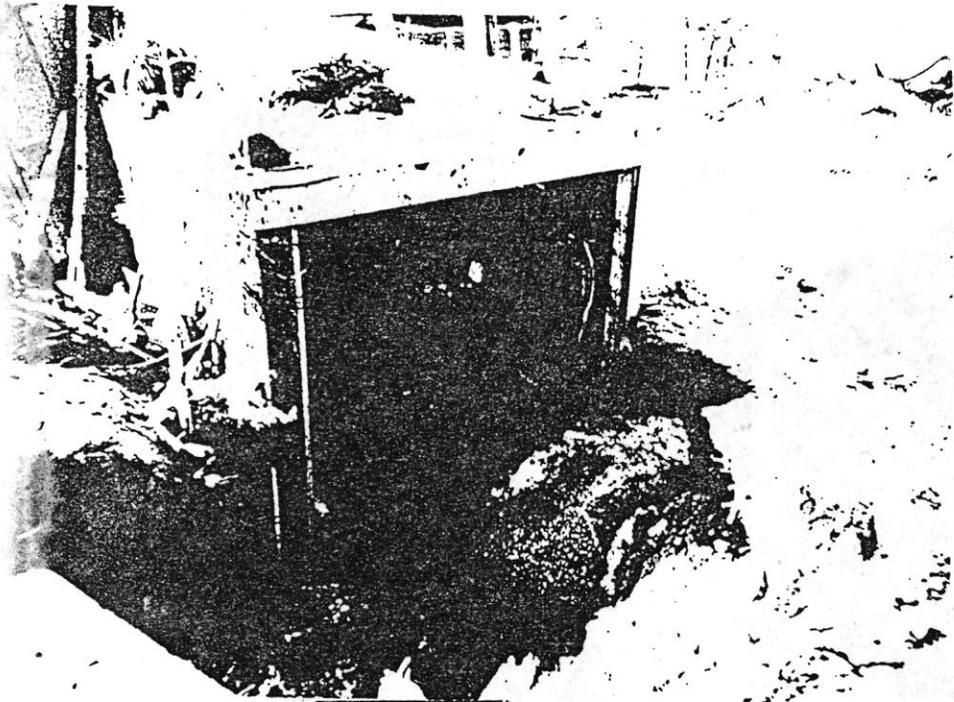
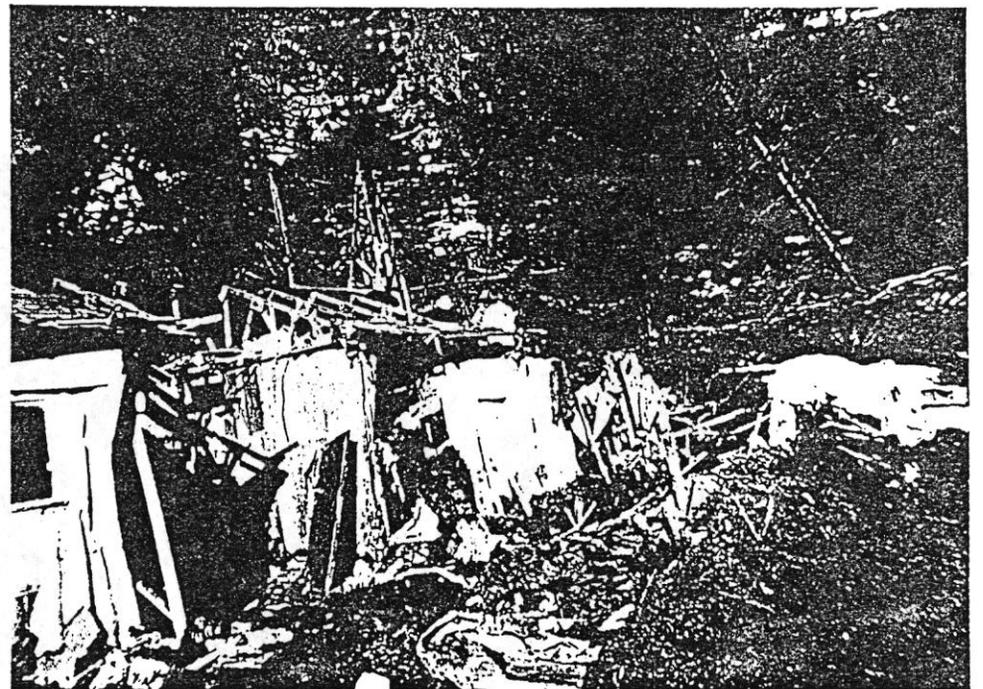
On January 1 - 3, 1997, a large volume of water and sediment passed from the main Banks Canyon onto the alluvial fan apex, then crossing Highway 55, and reaching the Payette river. The watershed contributed 12-14 acre feet of sediment and the water volume is estimated at 34.3 acre feet. Boulders up to five feet in diameter reached the area of the motel. Any structure on the alluvial fan that experienced this size-range of boulders was destroyed, as a

result. Other damage was caused by burial, due to the depth of the debris flow. This results in sediment and debris pouring through windows and doorways into structures, filling them with rock and mud. Scouring was also a problem, although it appeared that damage on the fan was mainly a factor of burial and impact forces.

Photographs of risk and damage in Lower Banks area.

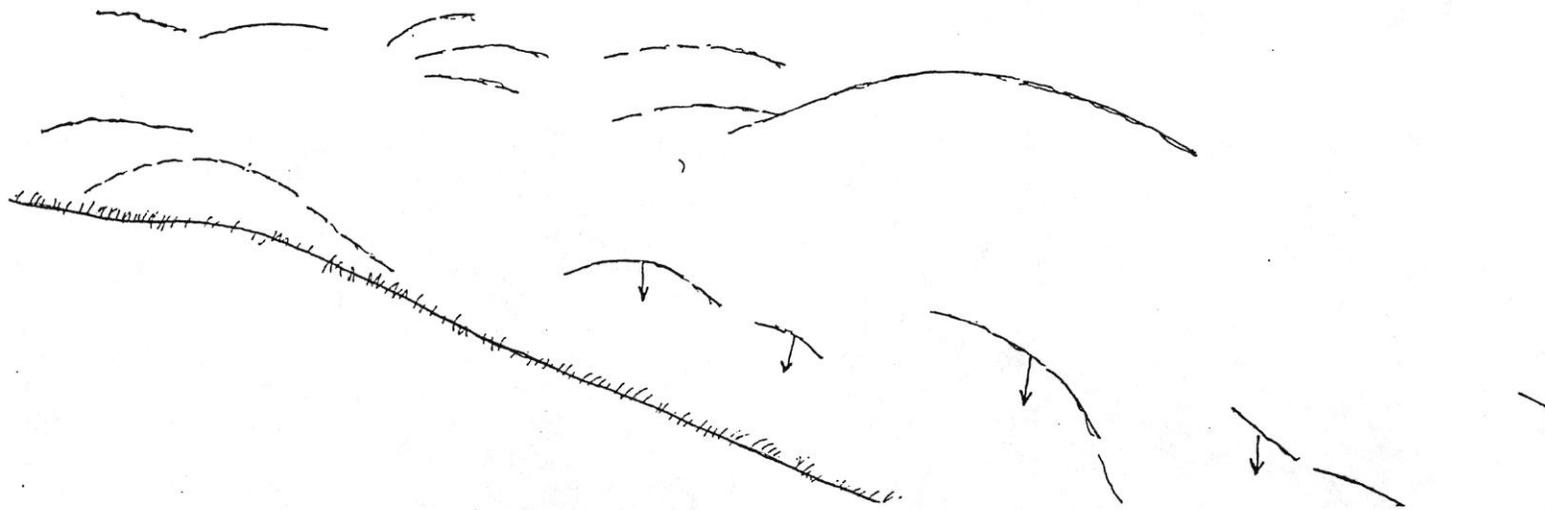
The snow-covered north-facing slopes are assumed to be underlain by frozen ground. This ground will thaw and will likely become unstable when that happens. The steeper slopes and more dense vegetation may contribute numerous slumps with tree debris into the channel bottom, which is assumed by the IAT to contribute to the ongoing imminent threat to human life below on the fan apex—in a sense, the second "barrel" of a "double-barrel shotgun."

TOP: Panoramic photograph of the north-facing slope of the main canyon above Lower Banks. Note the slump scarps in frozen soil. Undercut lower slopes slumped into the stream bottom, as shown. BOTTOM: Outline sketch of scarps shown in photograph above.
