RESOLUTION #97-20

DESIGNATION OF HAZARDOUS DEVELOPMENT SITE

Fema/State Interagency Technical Report

ALLUVIAL FAN COMPLEX DEBRIS FLOOD/FLOW POTENTIAL

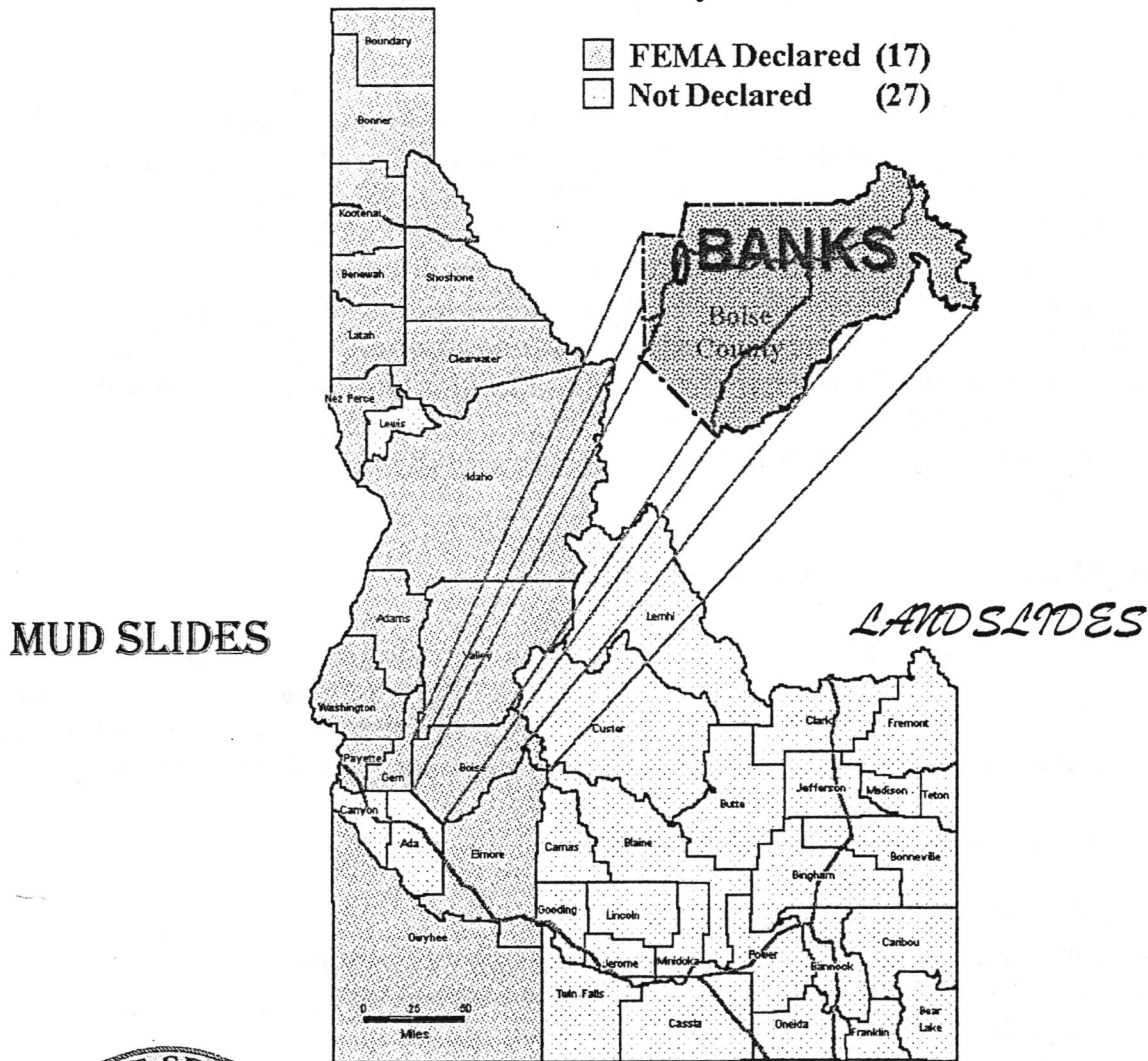
Debris Flow Damage
