## RESOLUTION #97-20

### DESIGNATION OF HAZARDOUS DEVELOPMENT SITE

## Fema/State Interagency Technical Report

### Boise County Debris Flow

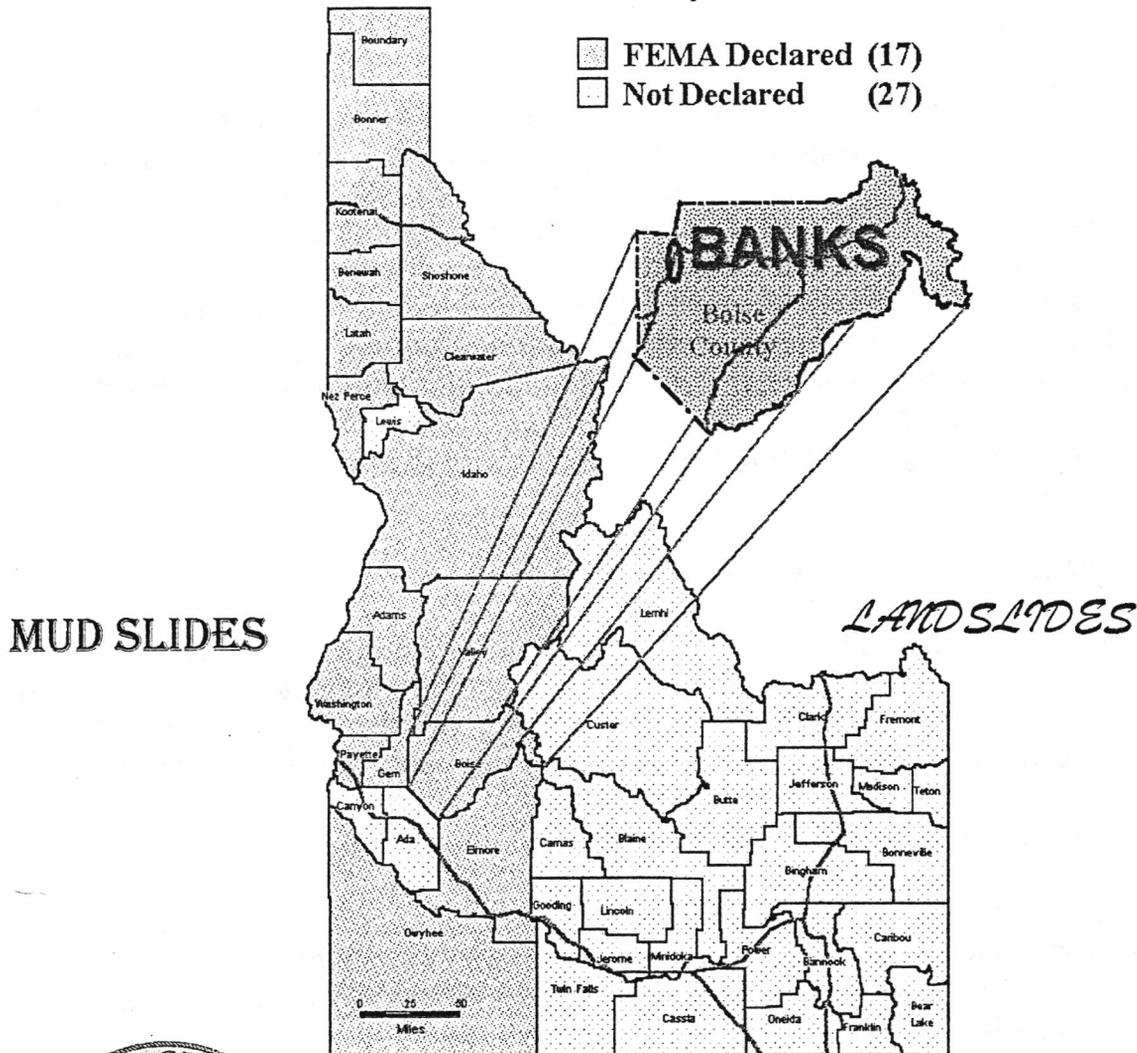
Debris Flow Damage

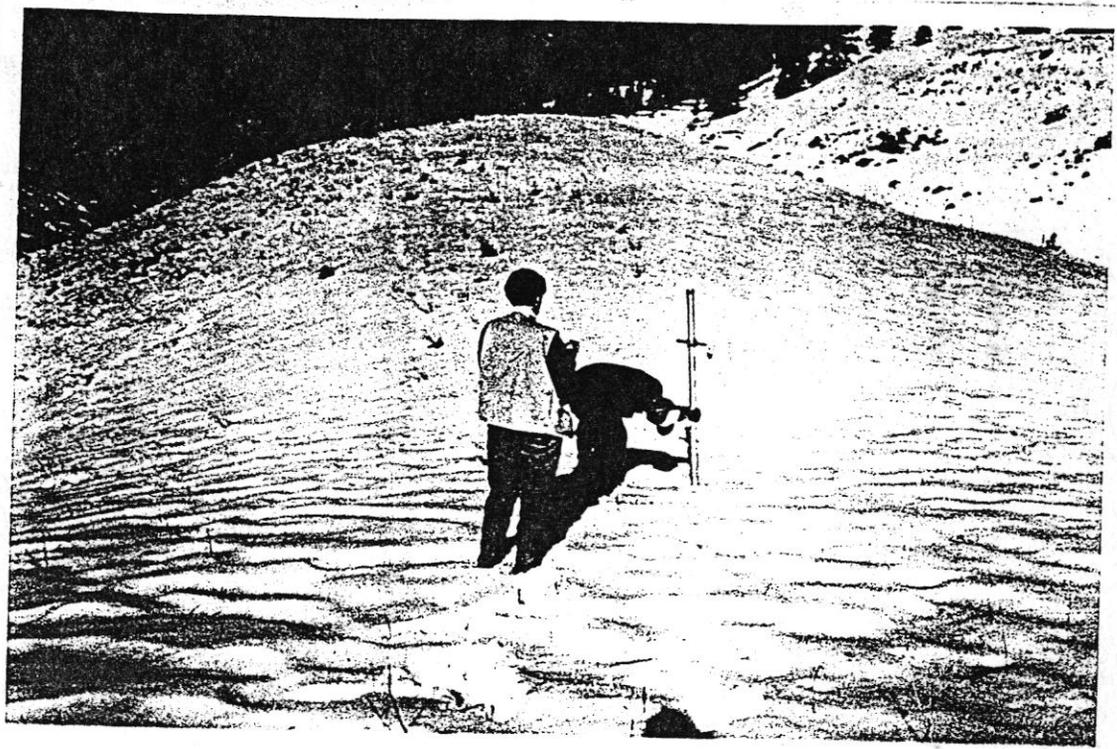
Top Photograph: Phil Morrissey (NRCS, Snow Survey Office) conducting snow survey in Lower Banks watershed. Lower Photograph: View of watershed areas above Lower Banks.

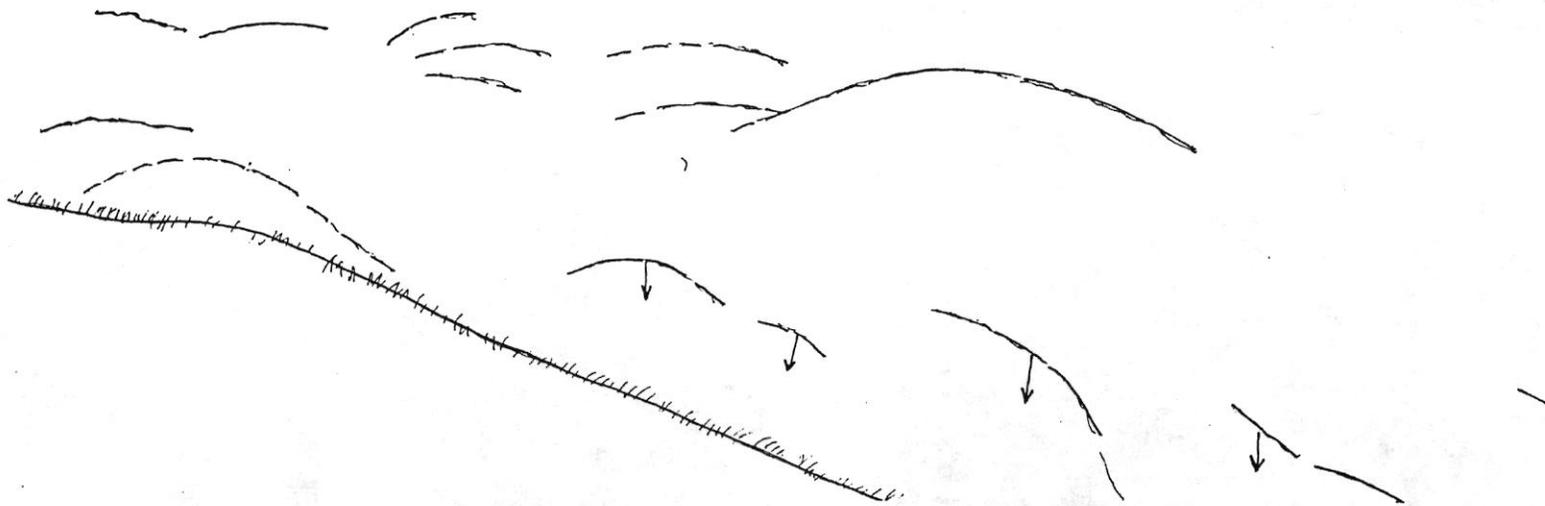
The snow-covered north-facing slopes are assumed to be underlain by frozen ground. This ground will thaw and will likely become unstable when that happens. The steeper slopes and more dense vegetation may contribute numerous slumps with tree debris into the channel bottom, which is assumed by the IAT to contribute to the ongoing imminent threat to human life below on the fan apex—in a sense, the second "barrel" of a "double-barrel shotgun."

TOP: Panoramic photograph of the north-facing slope of the main canyon above Lower Banks. Note the slump scarps in frozen soil. Undercut lower slopes slumped into the stream bottom, as shown. BOTTOM: Outline sketch of scarps shown in photograph above.
