DESIGNATION OF HAZARDOUS DEVELOPMENT SITE

Fema/State Interagency
Technical Report

Boise County Debris Flow

ALLUVIAL FAN COMPLEX DEBRIS FLOOD/FLOW POTENTIAL

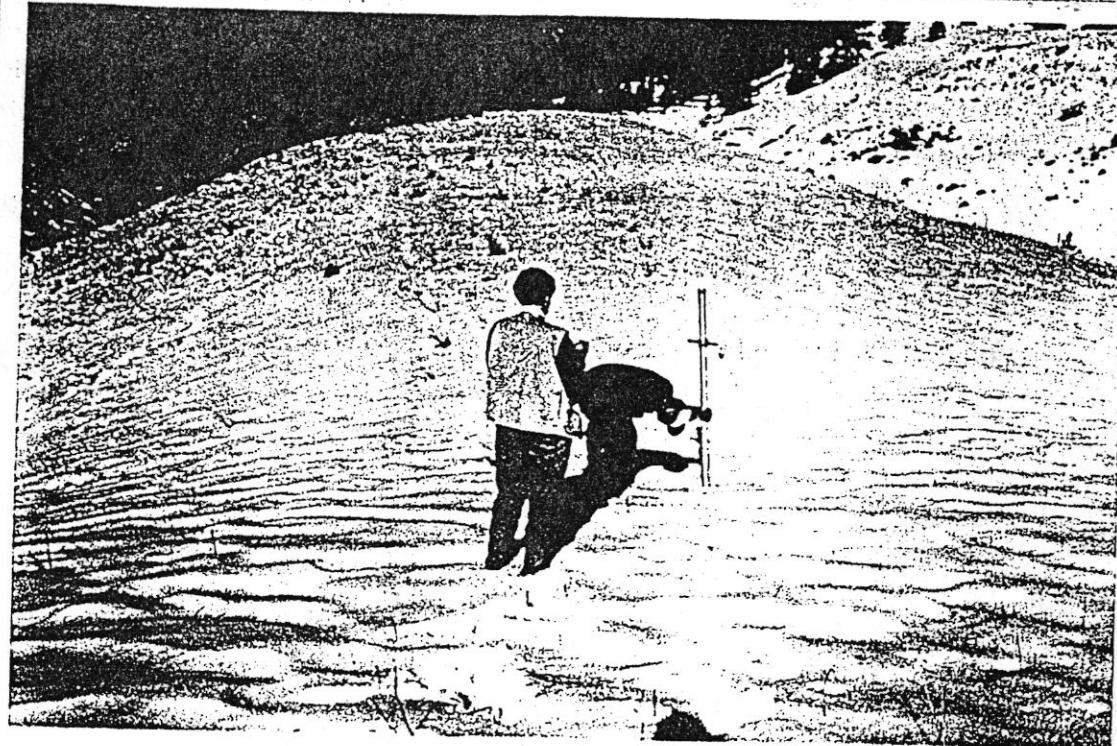
Top Photograph: Phil Morrisey (NRCS, Snow Survey Office) conducting snow survey in Lower Banks watershed. Lower Photograph: View of watershed areas above Lower Banks.

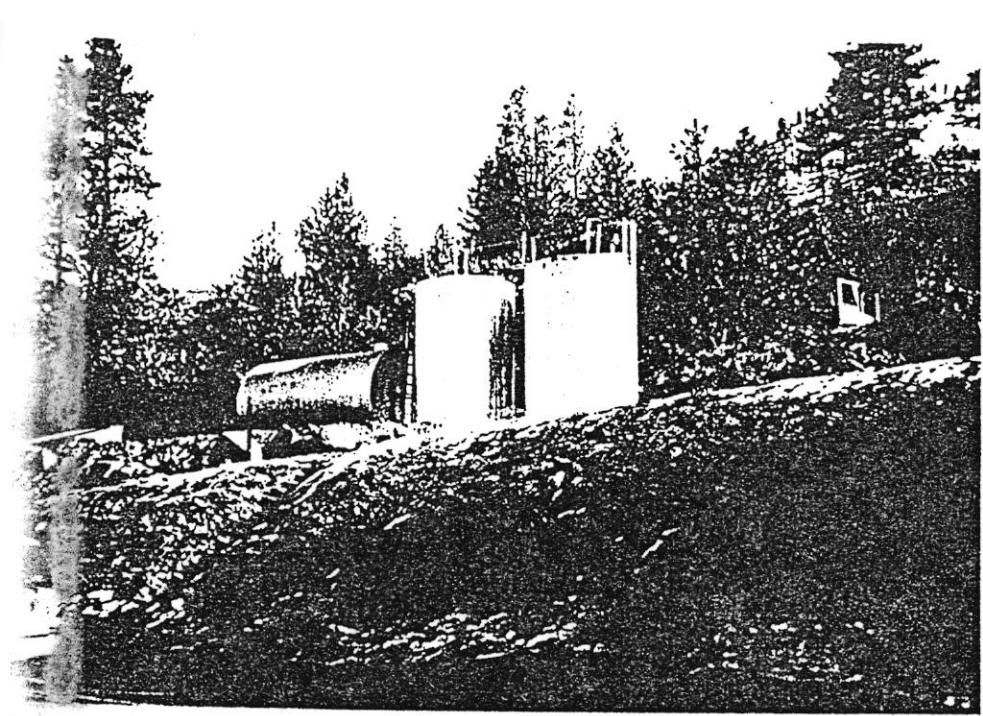
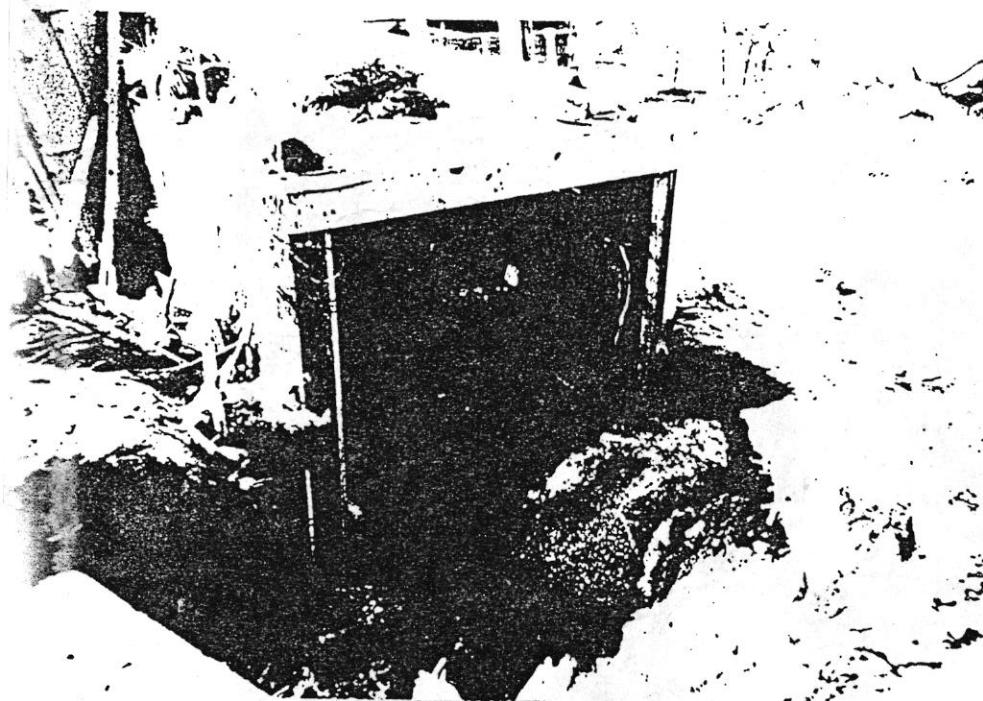
On January 1 - 3, 1997, a large volume of water and sediment passed from the main Banks Canyon onto the alluvial fan apex, then crossing Highway 55, and reaching the Payette river. The watershed contributed 12-14 acre feet of sediment and the water volume is estimated at 34.3 acre feet. Boulders up to five feet in diameter reached the area of the motel. Any structure on the alluvial fan that experienced this size-range of boulders was destroyed, as a

result. Other damage was caused by burial, due to the depth of the debris flow. This results in sediment and debris pouring through windows and doorways into structures, filling them with rock and mud. Scouring was also a problem, although it appeared that damage on the fan was mainly a factor of burial and impact forces.

Photographs of risk and damage in Lower Banks area.

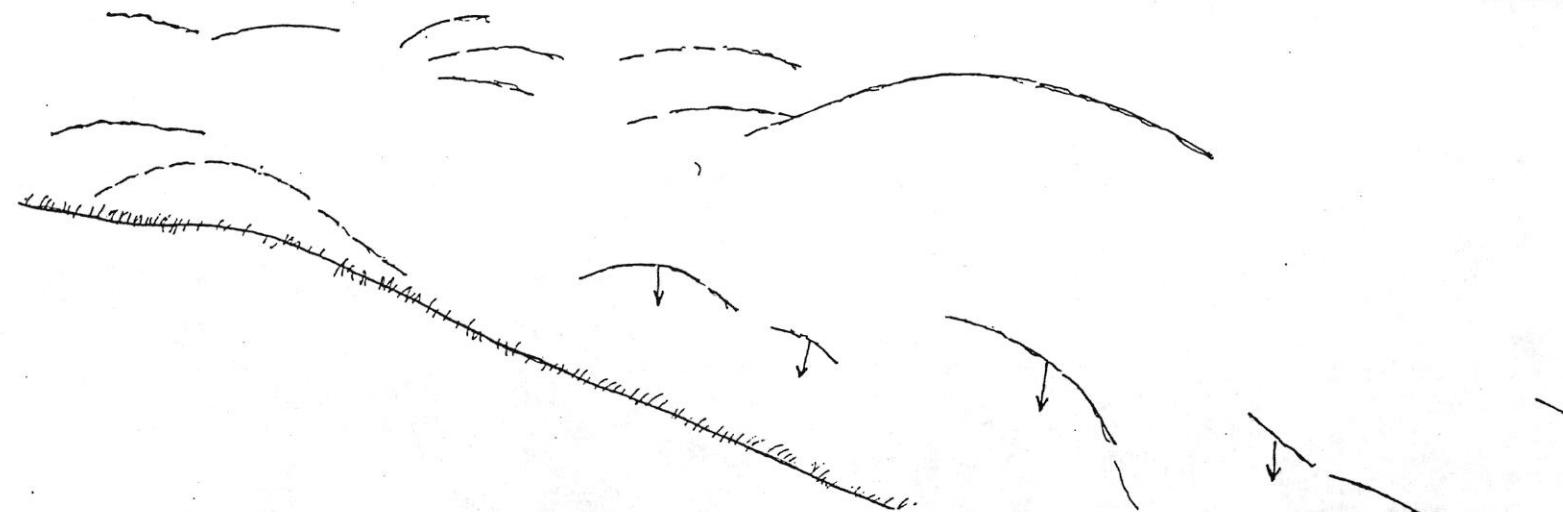
The snow-covered north-facing slopes are assumed to be underlain by frozen ground. This ground will thaw and will likely become unstable when that happens. The steeper slopes and more dense vegetation may contribute numerous slumps with tree debris into the channel bottom, which is assumed by the IAT to contribute to the ongoing imminent threat to human life below on the fan apex—in a sense, the second “barrel” of a “double-barrel shotgun.”

TOP: Panoramic photograph of the north-facing slope of the main canyon above Lower Banks. Note the slump scars in frozen soil. Undercut lower slopes slumped into the stream bottom, as shown. BOTTOM: Outline sketch of scarps shown in photograph above.
