# FEMA-DR-1154-ID

## Fema/State Interagency Technical Report

### Boise County Debris Flow

### ALLUVIAL FAN COMPLEX DEBRIS FLOOD/FLOW POTENTIAL

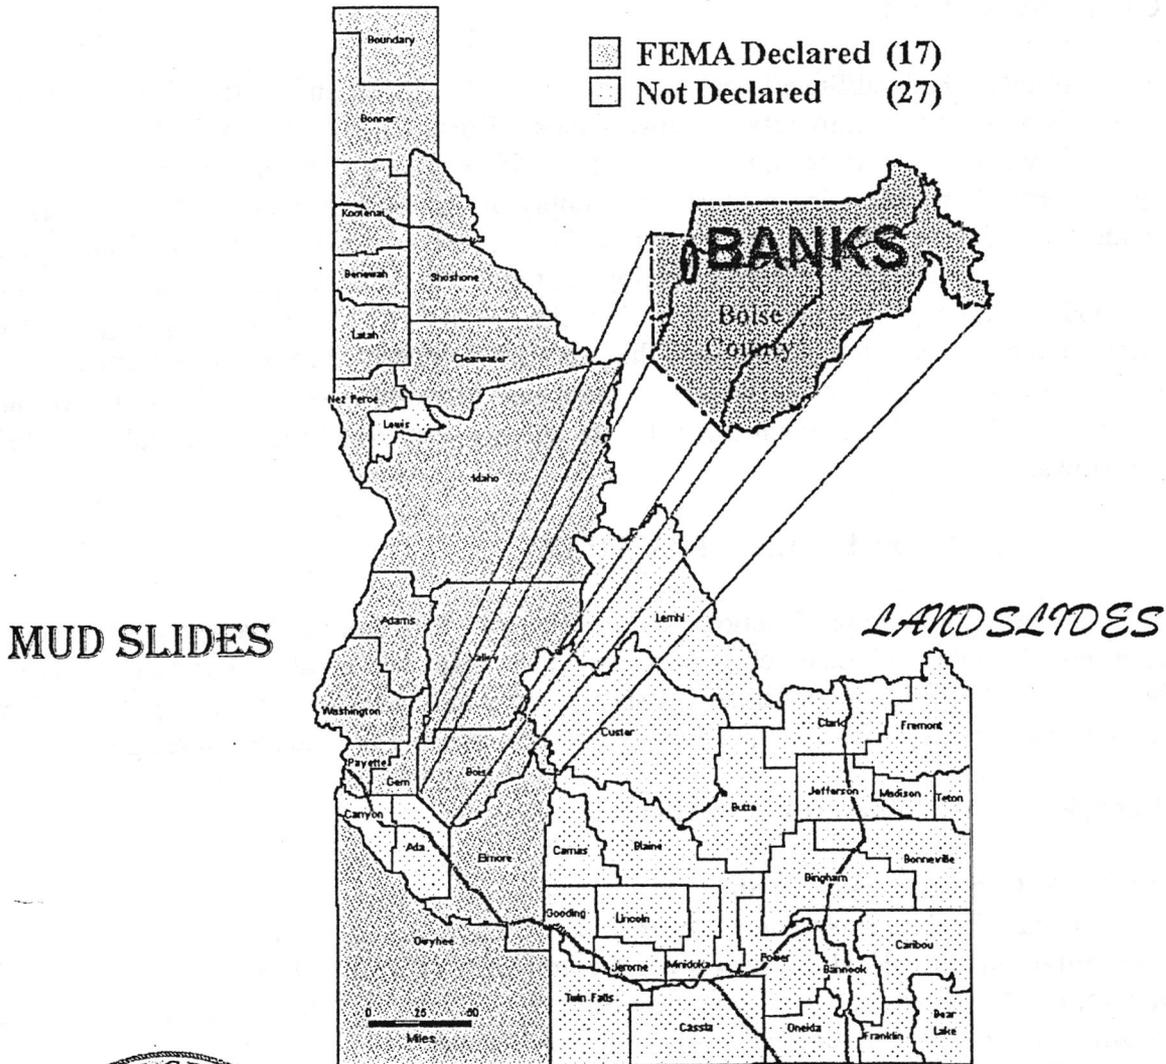
**Debris Flow Damage**

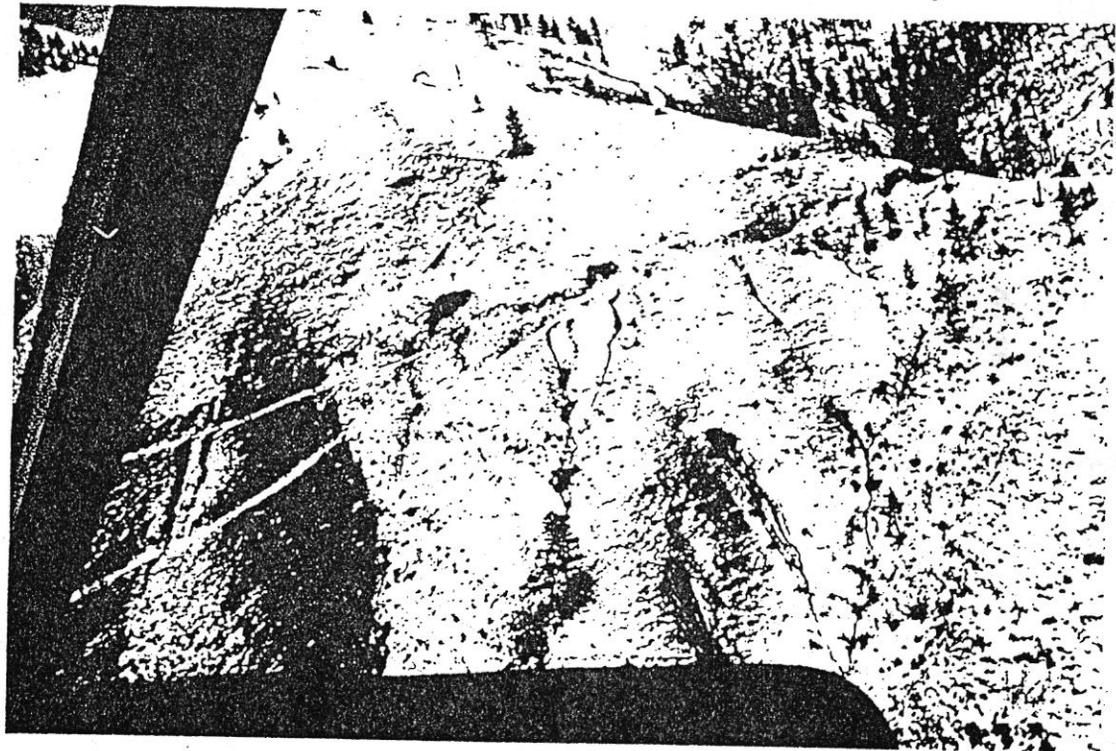
Top Photograph: Phil Morrissey (NRCS, Snow Survey Office) conducting snow survey in Lower Banks watershed. Lower Photograph: View of watershed areas above Lower Banks.

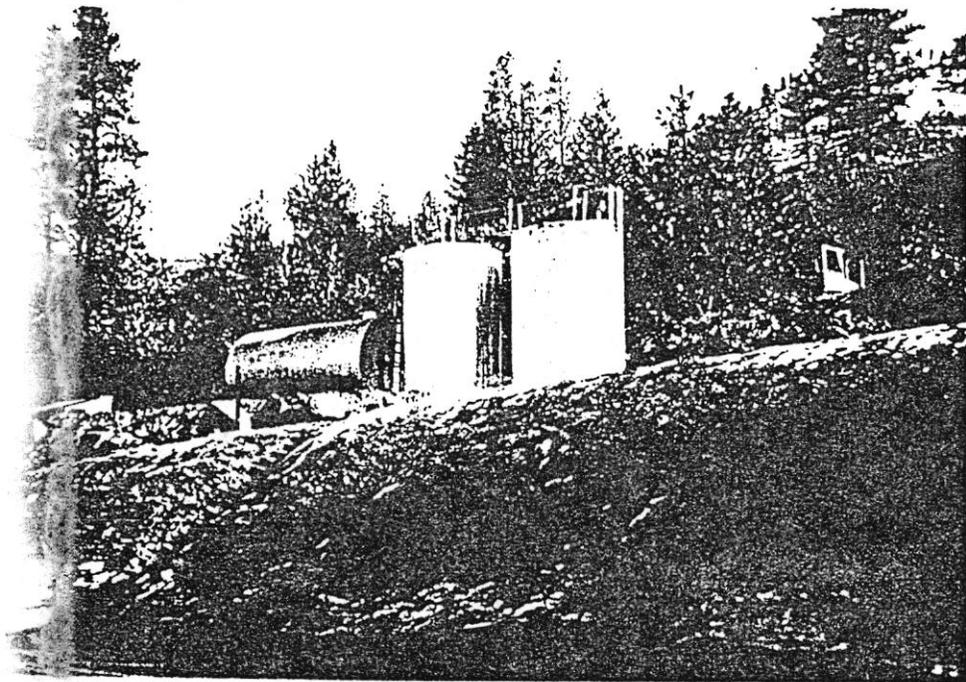
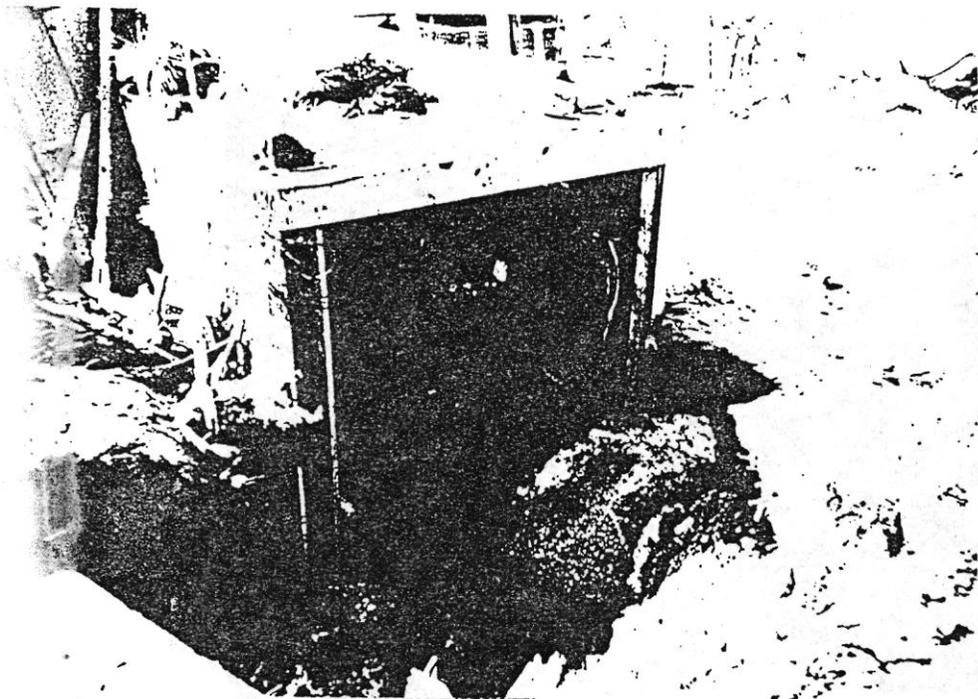
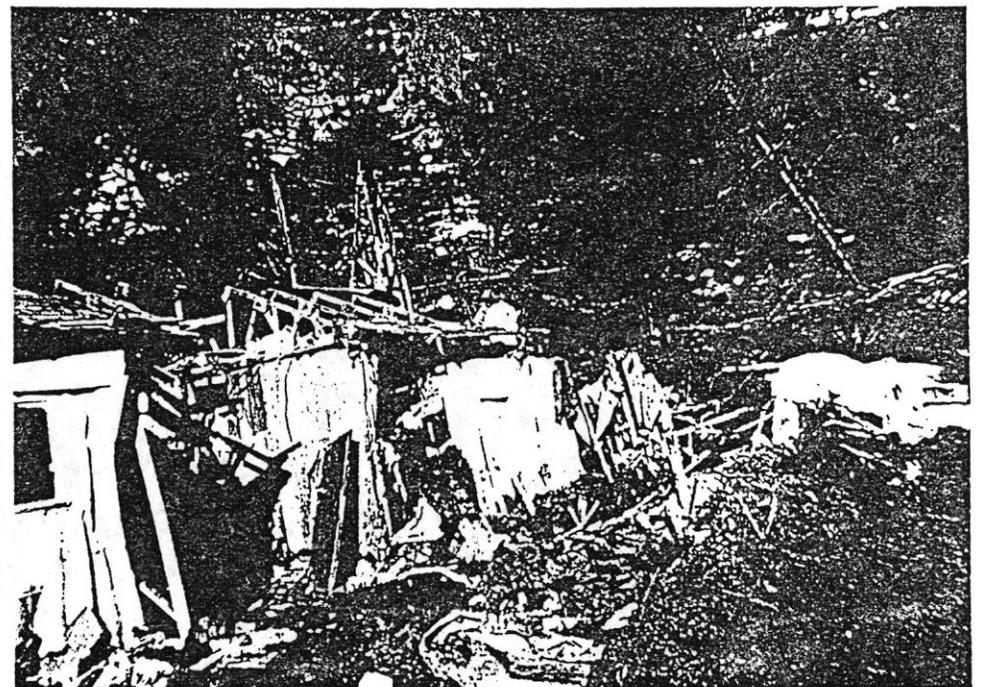
On January 1 - 3, 1997, a large volume of water and sediment passed from the main Banks Canyon onto the alluvial fan apex, then crossing Highway 55, and reaching the Payette river. The watershed contributed 12-14 acre feet of sediment and the water volume is estimated at 34.3 acre feet. Boulders up to five feet in diameter reached the area of the motel. Any structure on the alluvial fan that experienced this size-range of boulders was destroyed, as a

result. Other damage was caused by burial, due to the depth of the debris flow. This results in sediment and debris pouring through windows and doorways into structures, filling them with rock and mud. Scouring was also a problem, although it appeared that damage on the fan was mainly a factor of burial and impact forces.

Photographs of risk and damage in Lower Banks area.

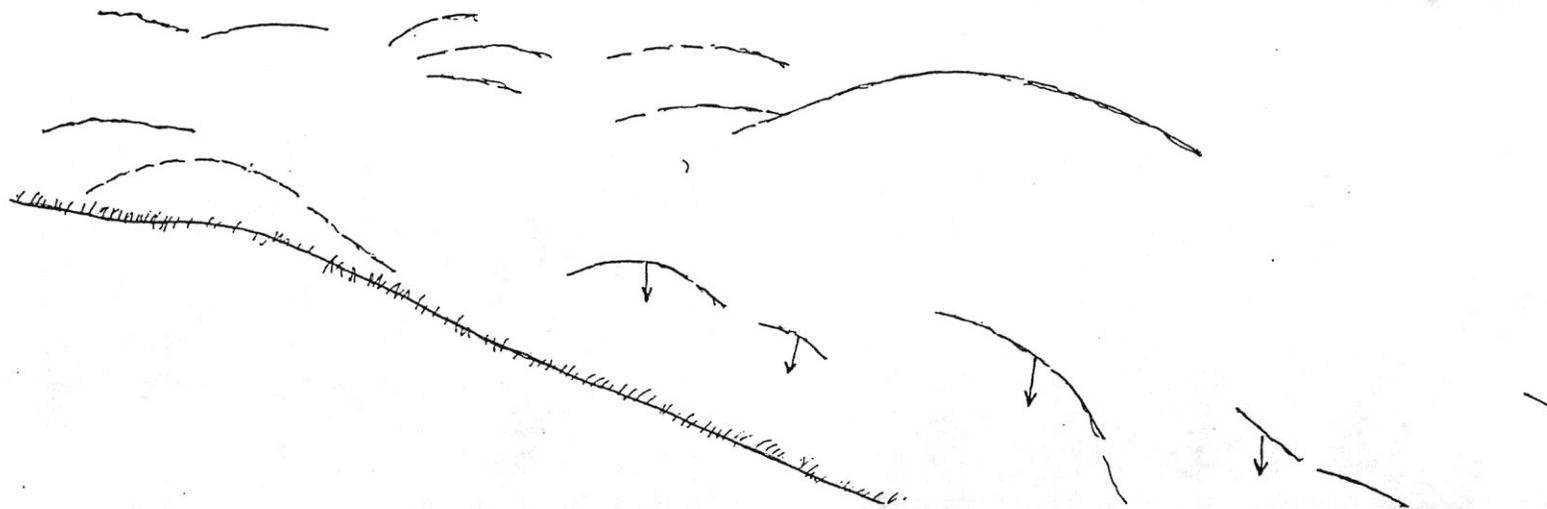
The snow-covered north-facing slopes are assumed to be underlain by frozen ground. This ground will thaw and will likely become unstable when that happens. The steeper slopes and more dense vegetation may contribute numerous slumps with tree debris into the channel bottom, which is assumed by the IAT to contribute to the ongoing imminent threat to human life below on the fan apex—in a sense, the second "barrel" of a "double-barrel shotgun."

TOP: Panoramic photograph of the north-facing slope of the main canyon above Lower Banks. Note the slump scarps in frozen soil. Undercut lower slopes slumped into the stream bottom, as shown. BOTTOM: Outline sketch of scarps shown in photograph above.
