RESOLUTION #97-8

DESIGNATION OF HAZARDOUS DEVELOPMENT SITE

## Fema/State Interagency Technical Report

### ALLUVIAL FAN COMPLEX DEBRIS FLOOD/FLOW POTENTIAL

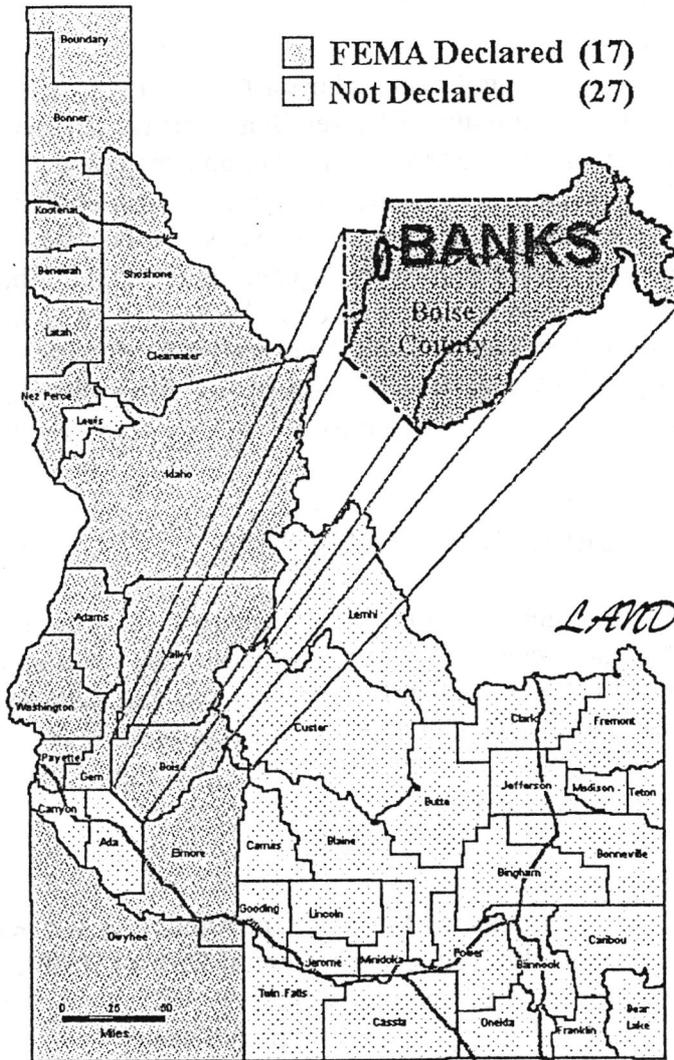
Debris Flow Damage

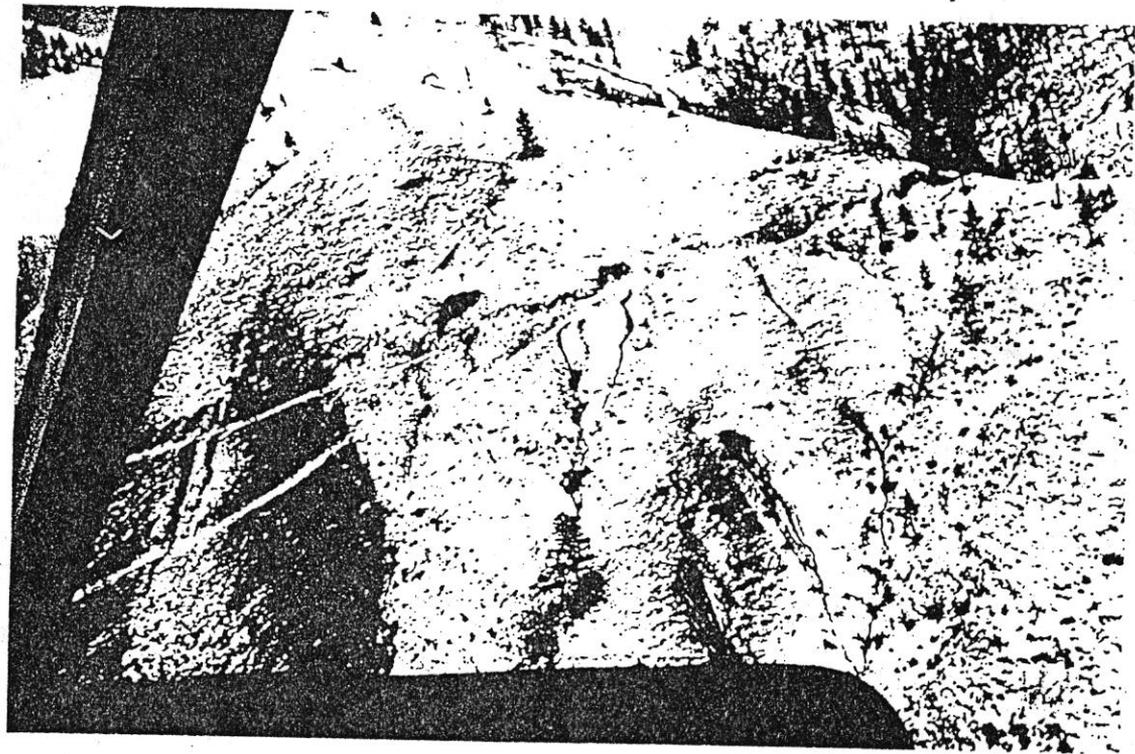
The Lower Banks watersheds are considered by the IAT to be damaged. This is an important point that relates to the concept of imminent threat to life and property, even on an ongoing basis for several years to come. The damage resulted from the deep and extensive burn that occurred five years ago, and from which the trees of the watershed have not yet recovered. The damage also resulted from the December and early January weather, snow and rainfall, and warm temperatures. The watershed reacted to the latter conditions with rapid runoff, undercutting of stream banks, slumping, natural dams, and flood surges onto the alluvial fan below. Many active and incipient slumps still exist on the south-facing slopes of the two canyons, and evidence of slumping is present in the north-facing frozen slopes.

Top Photograph: Phil Morrissey (NRCS, Snow Survey Office) conducting snow survey in Lower Banks watershed. Lower Photograph: View of watershed areas above Lower Banks.

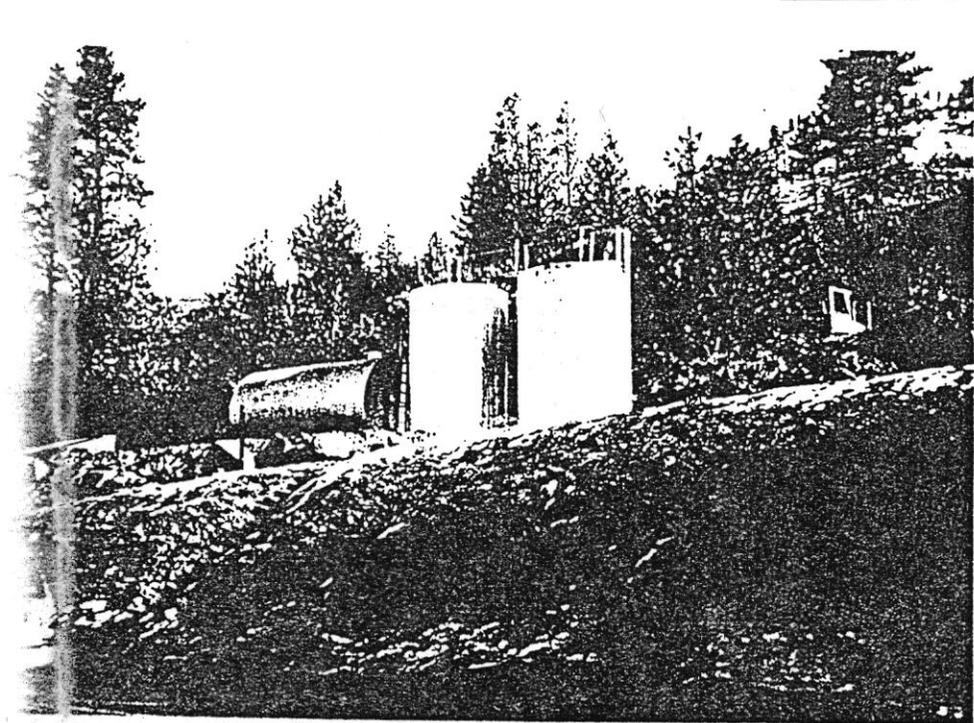
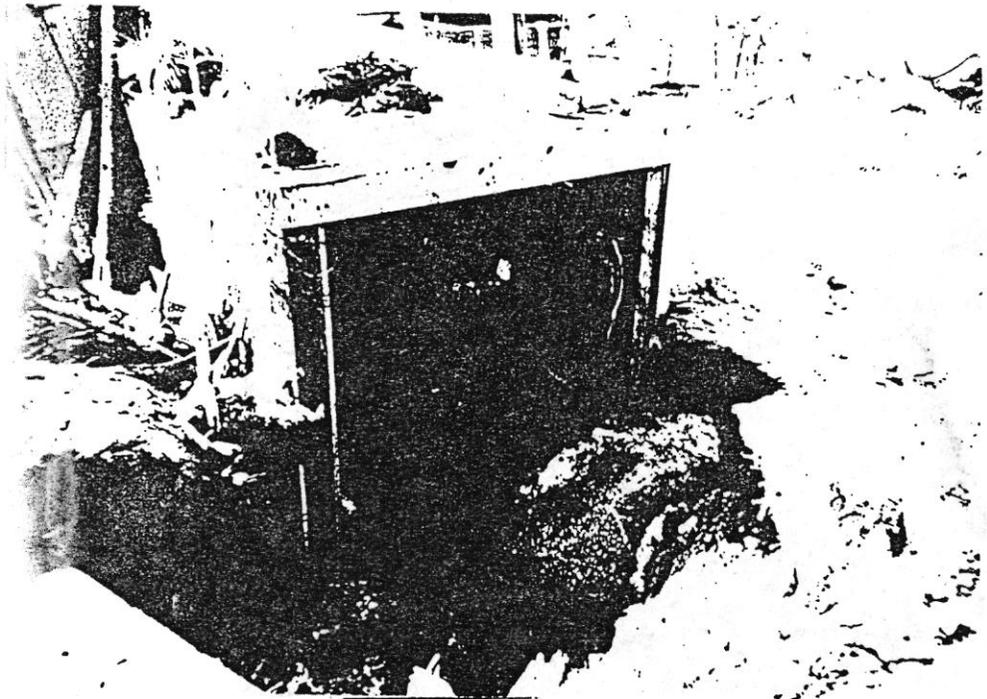
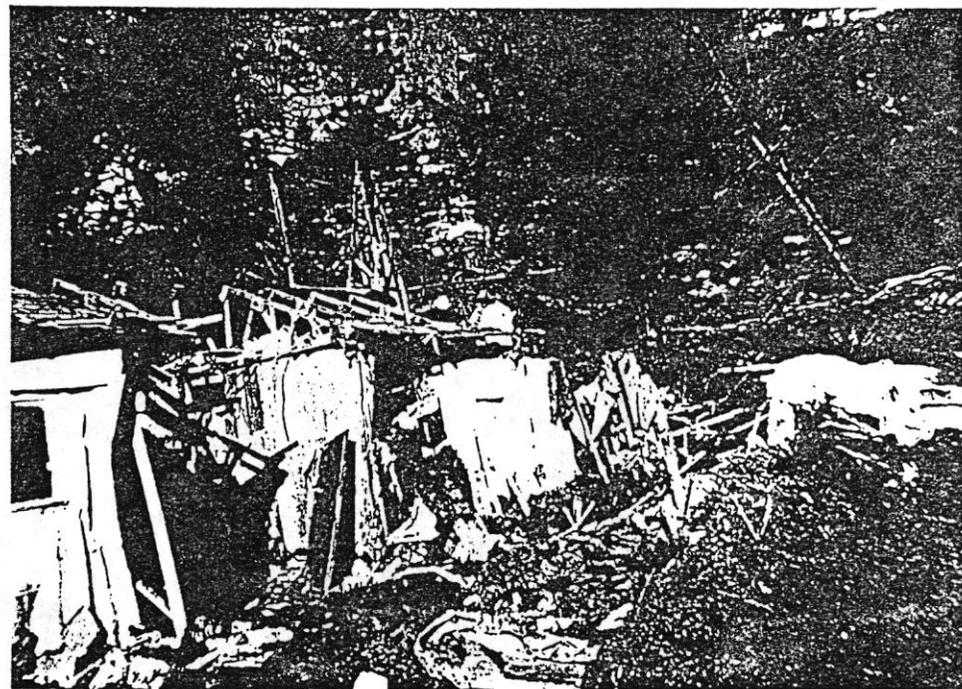
On January 1 - 3, 1997, a large volume of water and sediment passed from the main Banks Canyon onto the alluvial fan apex, then crossing Highway 55, and reaching the Payette river. The watershed contributed 12-14 acre feet of sediment and the water volume is estimated at 34.3 acre feet. Boulders up to five feet in diameter reached the area of the motel. Any structure on the alluvial fan that experienced this size-range of boulders was destroyed, as a

result. Other damage was caused by burial, due to the depth of the debris flow. This results in sediment and debris pouring through windows and doorways into structures, filling them with rock and mud. Scouring was also a problem, although it appeared that damage on the fan was mainly a factor of burial and impact forces.

Photographs of risk and damage in Lower Banks area.

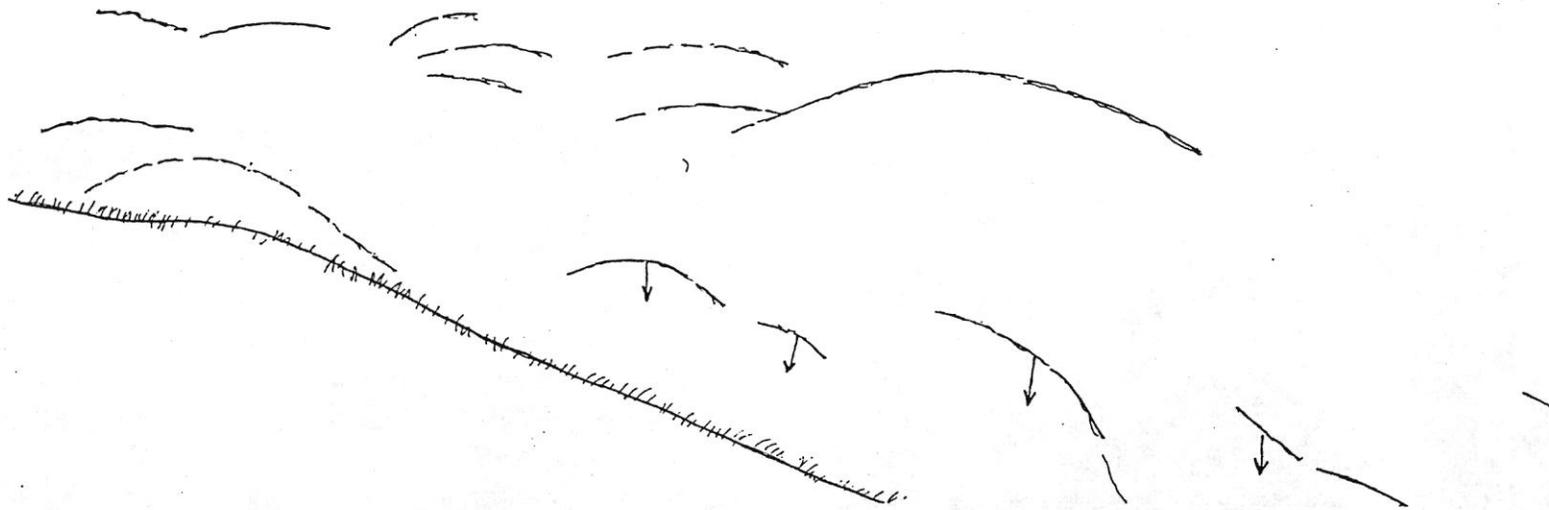
The snow-covered north-facing slopes are assumed to be underlain by frozen ground. This ground will thaw and will likely become unstable when that happens. The steeper slopes and more dense vegetation may contribute numerous slumps with tree debris into the channel bottom, which is assumed by the IAT to contribute to the ongoing imminent threat to human life below on the fan apex—in a sense, the second "barrel" of a "double-barrel shotgun."

TOP: Panoramic photograph of the north-facing slope of the main canyon above Lower Banks. Note the slump scarps in frozen soil. Undercut lower slopes slumped into the stream bottom, as shown. BOTTOM: Outline sketch of scarps shown in photograph above.
