RESOLUTION #97-19

DESIGNATION OF HAZARDOUS DEVELOPMENT SITE

Fema/State Interagency Technical Report

ALLUVIAL FAN COMPLEX DEBRIS FLOOD/FLOW POTENTIAL

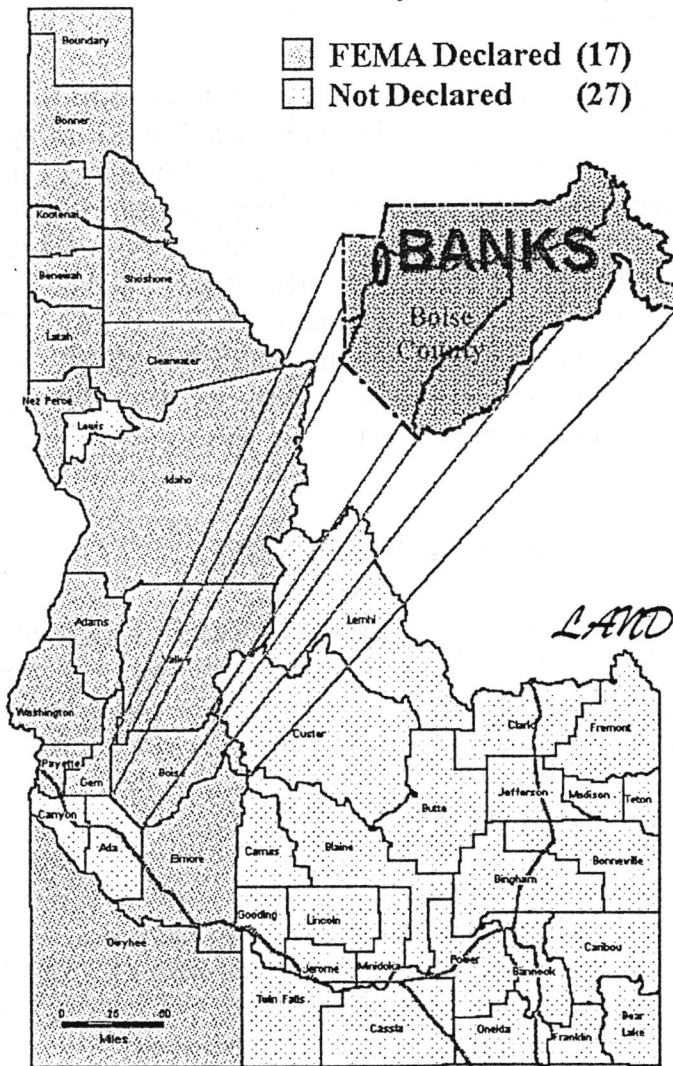
Debris Flow Damage
