RESOLUTION #97-22

DESIGNATION OF HAZARDOUS DEVELOPMENT SITE

Fema/State Interagency Technical Report

Boise County Debris Flow January 1-3, 1997

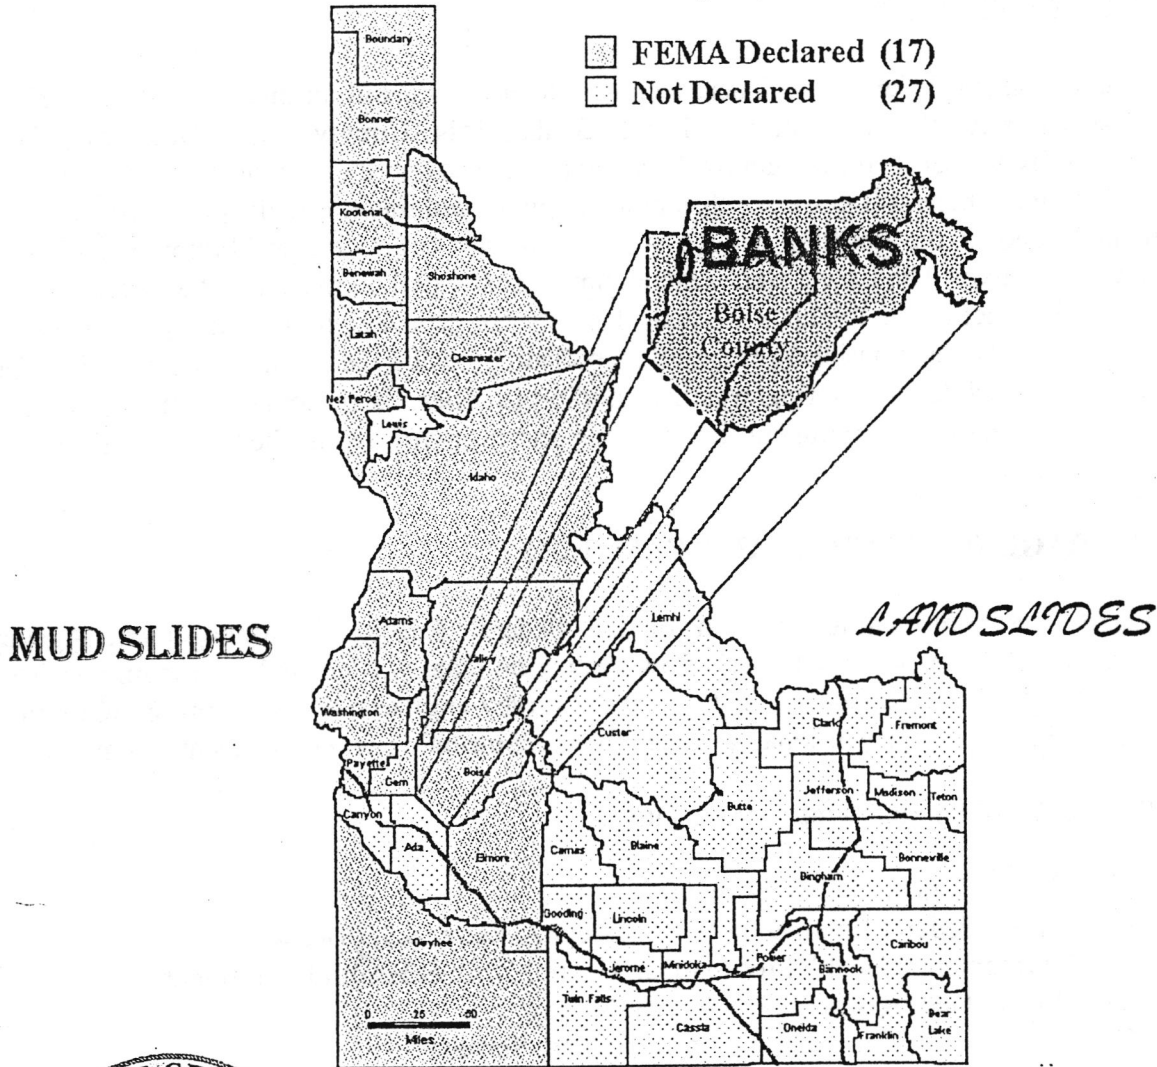
Debris Flow Damage
