RESOLUTION #97-23

DESIGNATION OF HAZARDOUS DEVELOPMENT SITE

Fema/State Interagency Technical Report

ALLUVIAL FAN COMPLEX DEBRIS FLOOD/FLOW POTENTIAL

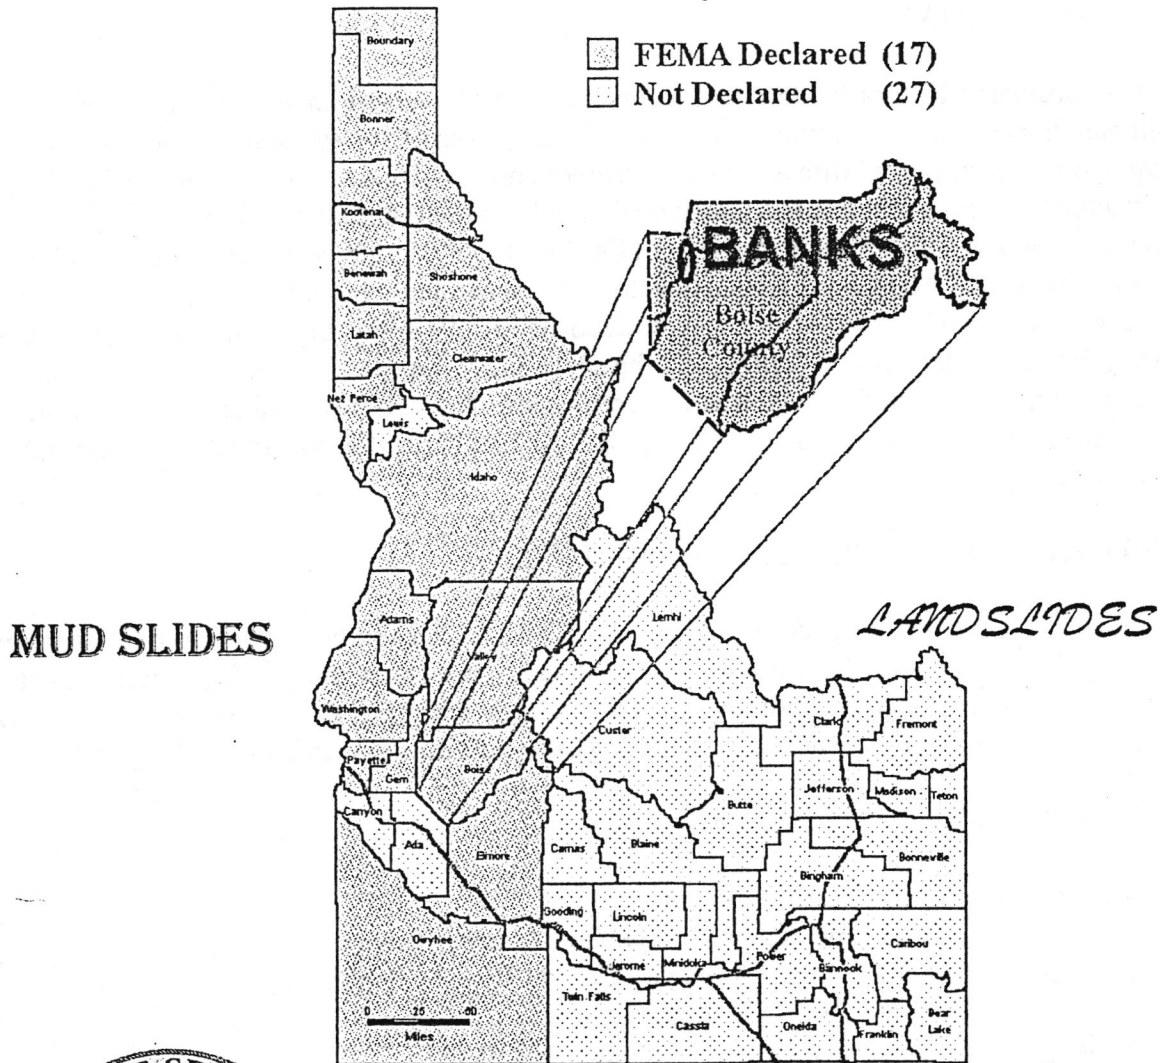
Debris Flow Damage
