# FEMA-DR-1154-ID

## Fema/State Interagency Technical Report

### Boise County Debris Flow

### ALLUVIAL FAN COMPLEX DEBRIS FLOOD/FLOW POTENTIAL

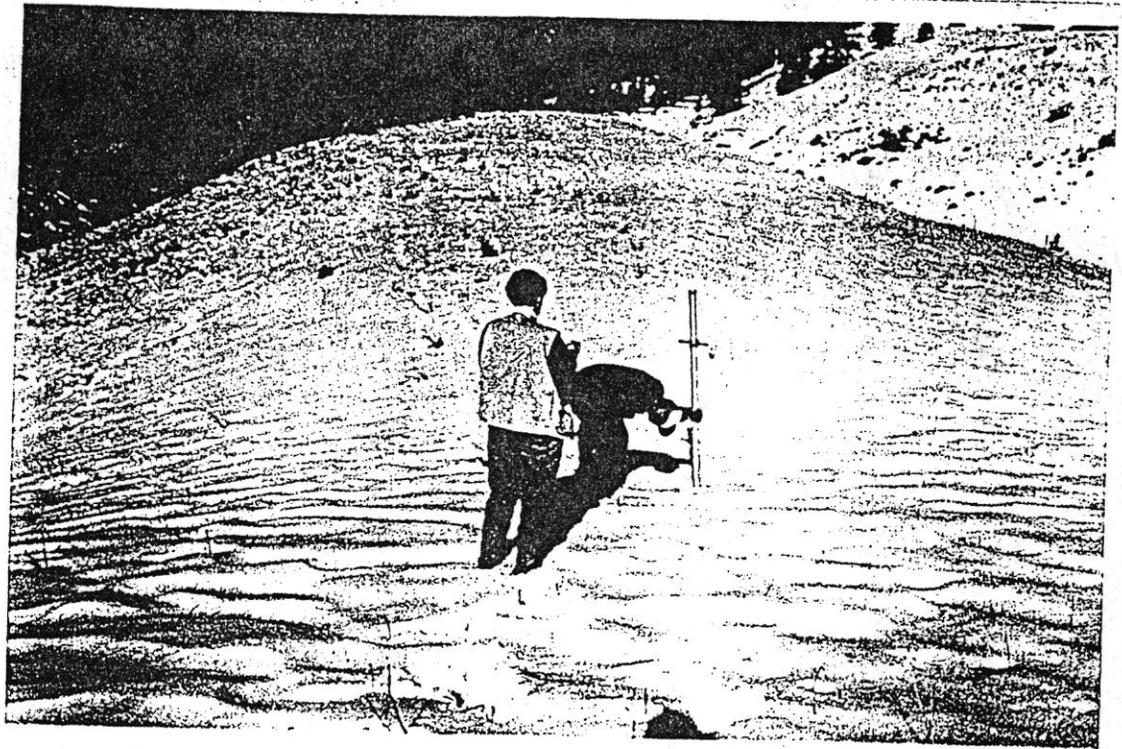
Top Photograph: Phil Morrissey (NRCS, Snow Survey Office) conducting snow survey in Lower Banks watershed. Lower Photograph: View of watershed areas above Lower Banks.
